| TSB150158 |

Bosch® Aftertreatment Diesel Exhaust Fluid (DEF) Dosing Pump with Unidentified Fluid at Seams

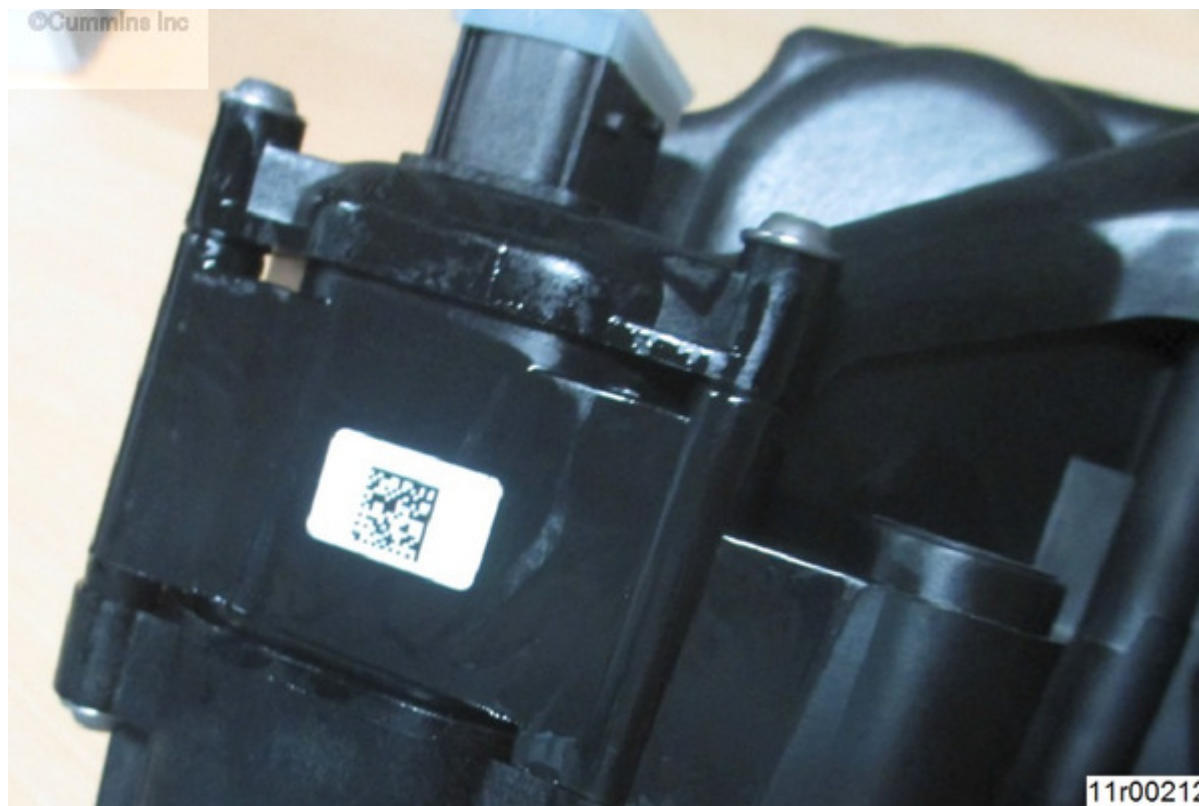
Figure 1, Example of Plasticizer at the Seams of the Aftertreatment DEF Dosing Unit

Plasticizer is a chemical used for sealing the aftertreatment DEF dosing unit seams. The plasticizer will appear

as an oily or grease like substance. See Figure 2 below.

A DEF leak can be verified by visible signs of DEF crystallization. This will appear as white deposits

Plasticizer at the seams of the aftertreatment DEF dosing unit is normal and does **not** indicate a malfunction.
