| TSB150171 |

High Mount Turbochargers with Top Mount Turbocharger Actuator - Lubricating Oil Found at Turbocharger Sector Gear and Turbocharger Actuator Gear When Turbocharger Actuator is Removed

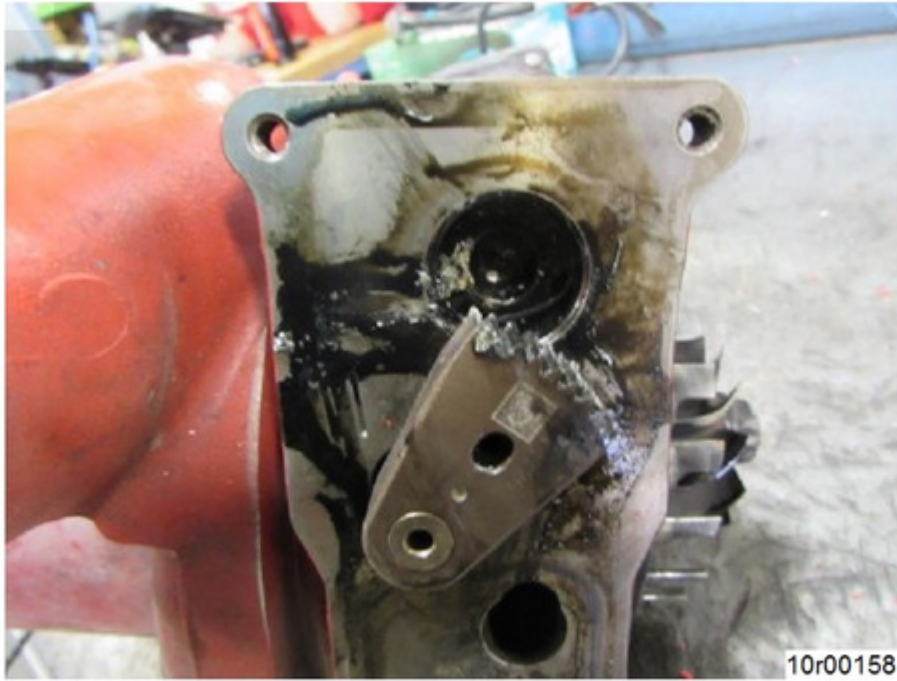
During troubleshooting on engines equipped with high mount turbochargers with top mount turbocharger actuators, lubricating oil has been found around the turbocharger sector gear and the variable geometry turbocharger actuator gear. This is normal and does **not** indicate a malfunction has occurred.

Figure 1, Acceptable Lubricating Oil Leakage Around the Turbocharger Sector Gear

Turbochargers and variable geometry turbocharger actuators should **not** be replaced if lubricating oil is found as shown in Figure 1 and Figure 2 above. For confirmation of actual lubricating oil leak from the turbocharger or turbocharger actuator:

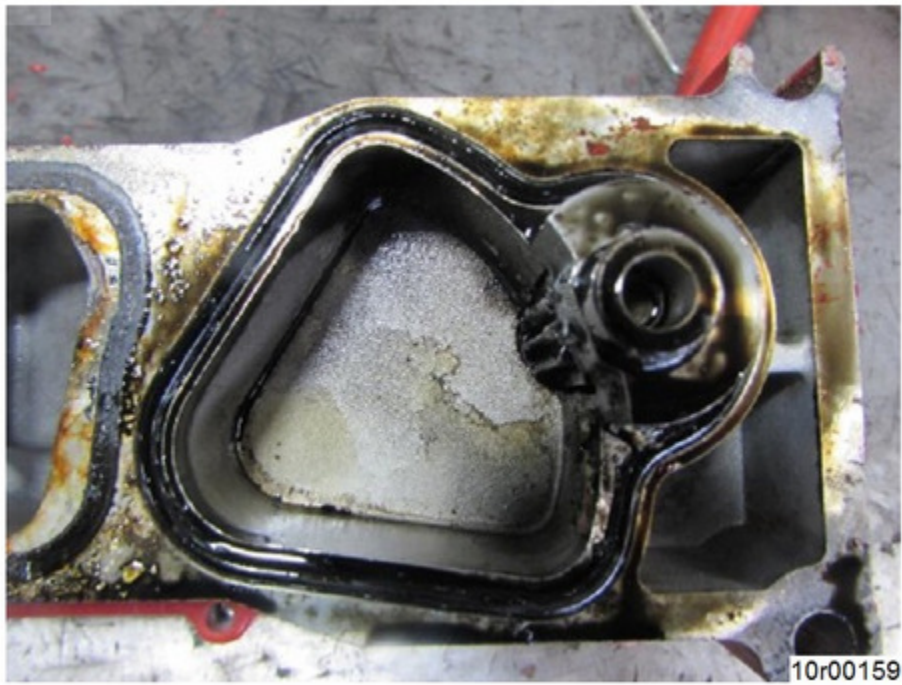
Figure 2, Acceptable Lubricating Oil Leakage Around the Variable Geometry Turbocharger Actuator Sector Gear
