Service Bulletin

101 East Seneca Bancroft, IA 50517	Bulletin #: SB000003	Date: December 7, 2015
Prepared by: Bob Mortenson	Phone # 515-885-2398	Page: 1

Subject:

Inform Aluma dealers and owners that 8605T, 8610T and 8612T trailers may have misaligned welds that may contribute to a failure of the trailer's axle mount weldment.

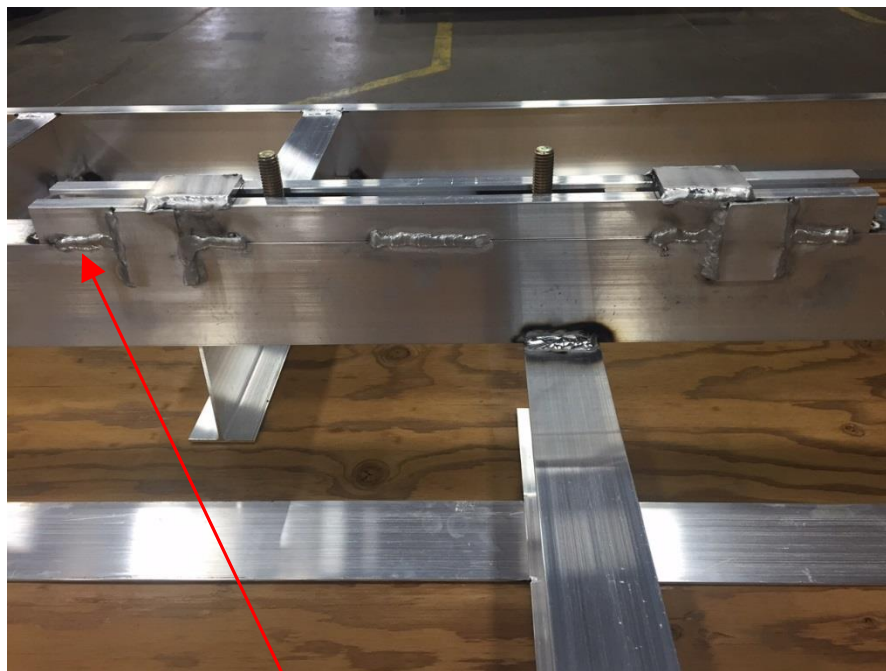
- 2.0 Remove and secure tires and hardware to be reinstalled later in step 8.
- 3.0 Inspect inside weld joint of axle mounts and U-channels for misalignment of weld or any cracks in welds. See Figure 1. If any defects are present proceed to inspecting axle mount outside welds and verify that there are no signs of base material damage. Repair all suspect welds using step 6. See Figures 3 and 4.

Option 1: flat strap configuration.
Inspect location of weld in joint.

- 4.0 Add flat strap to inside of axle mount as shown in Figure 1 and 2. Depending on condition of welds found in steps 5 or 6.
 - 4.1 Option 1: Flat strap must be located 2 inches from end of axle mount if flat strap can be placed flat onto axle mount and U-channel and then weld.

- 4.2 Option 2: flat strap is to mount next to end of weld on axle mount bracket. Weld joint using a 1/4" butt weld.
- 5.0 For any misaligned welds prepare surface to be rewelded. All welds shall be centrally located in joints. This will provide weld leg length and groove weld to ensure joint penetration necessary for an acceptable weld. Weld joint using 1/4" butt weld at least 3 inches long.

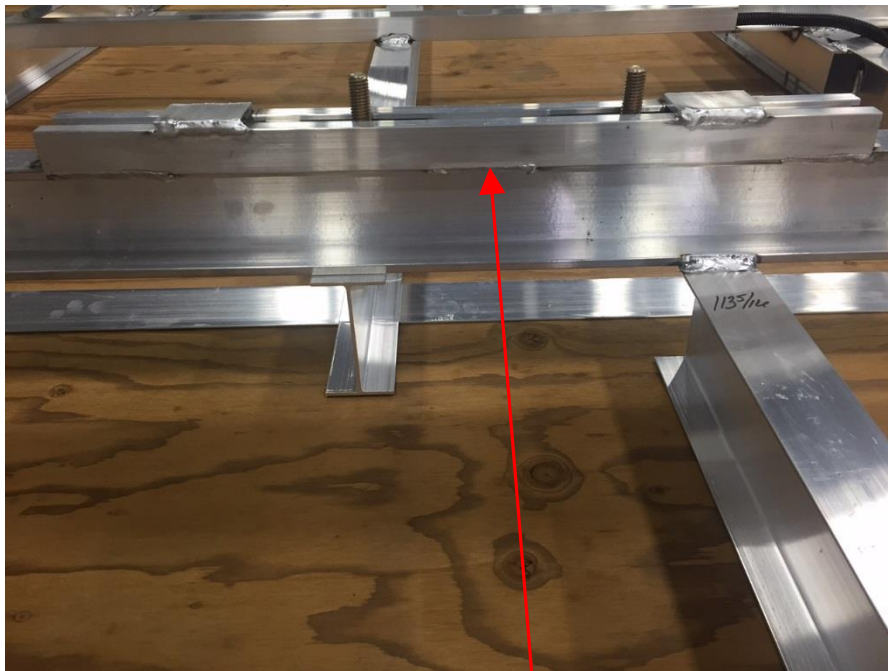
Figure 3

Outside axle mount: inspect for poor quality welds.

- 6.0 For any cracked or poor quality welds, grind cracked or poor quality weld and prepare any surrounding surface areas to be welded. Weld joint using 1/4" butt or fillet weld at least 3 inches long.
- 7.0 Person performing retrofit should be qualified and proficient aluminum welder. **Caution:** Use appropriate PPEs when preparing surface and welding. **Note:** Ensure that wiring harness is not damaged during welding.
- 8.0 Reinstall tires torque lug nuts to 110 ft/lbs. For more detailed information, refer to Aluma Owner's manual.
- 9.0 Verify work has been completed and all tools and hardware is secured. Raise trailer and remove jack stands.
- 10.0 Lower trailer and perform driving functional test to verify trailer is traveling correctly.
- 11.0 For more detailed information, always refer to Aluma Owner's Manual.
