Service Bulletin

101 East Seneca Bancroft, IA 50517	Bulletin #: 100715	Date: 10-07-15
Prepared by: Bob Mortenson	Phone # 515-885-2398	Page: 1

Inform Aluma dealers and owners that 5410T tilt trailer may have missing weld that may contribute to a failure of the trailer’s tongue weldment.

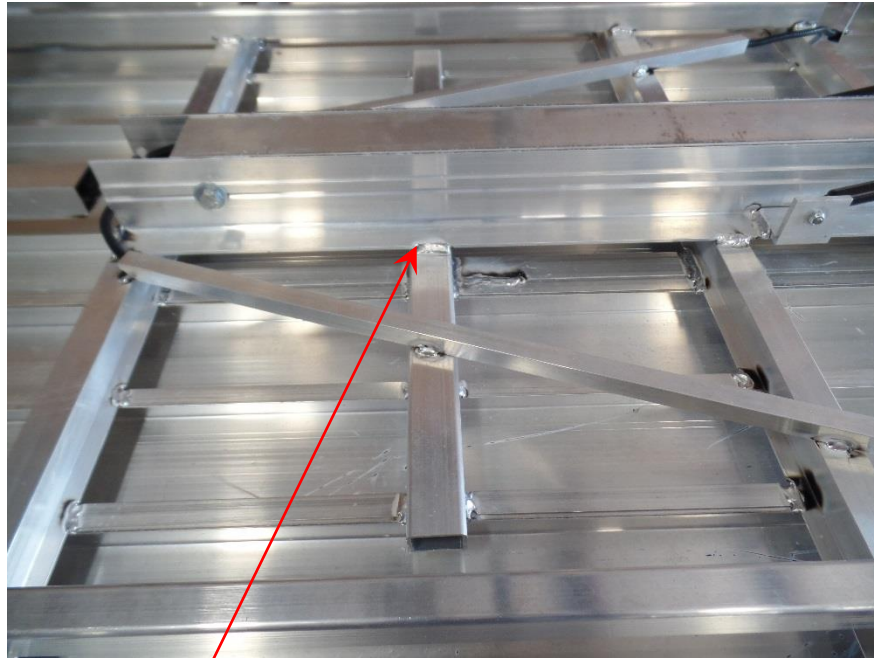
Figure 1

Inspect weld and base material

- 2.0 Inspect all welds and base material on tongue retainer and trailer frame to ensure no signs of damage has occurred. See Figure 1, 2 and 3. Prepare surface areas that are to be welded. Person performing retrofit should be qualified and proficient aluminum welder. **Caution:** Use appropriate PPEs when preparing surface and welding.

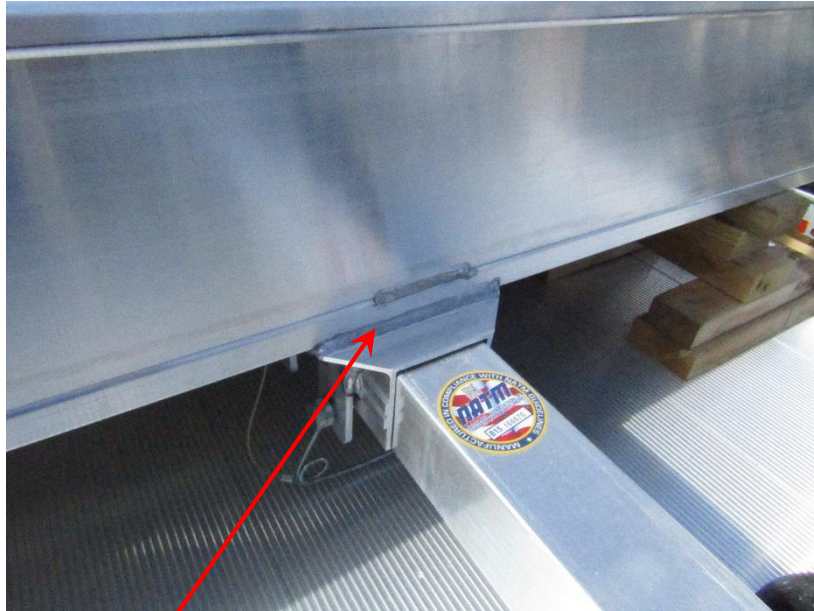
Figure 3

Inspect weld and base material
