| Instr. Title: | Startrans Cap Separation Repair | | | Release Date: | 6/30/2015 |
| Originator: | Corporate | WI #: | 109 | Revision Level: | A |

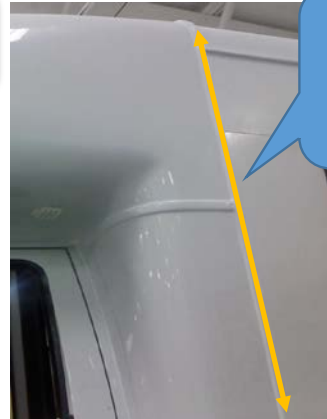
Condition to be Repaired  
**This condition must be present to request repair reimbursement.**

Remove RVL nested here between the pieces.  
If unpainted, it can be reused. Replace with new if the RVL is painted.

Remove the exterior trim cover(RVL).

If the RVL is not painted it can be reinstalled. If it is painted, the removal process will cause the paint to crack and the piece cannot be reinstalled. A new RVL must be installed.

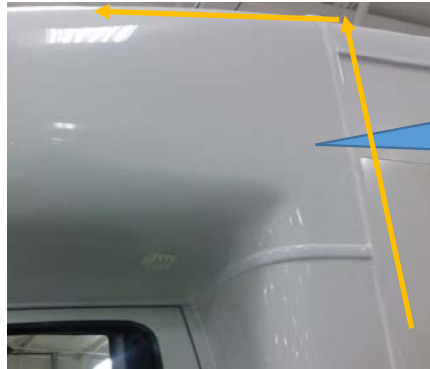
Add fasteners here, then add fastener in between each old fastener hole up the side, along the roof, and along the passenger side.

Add new self tapping screws in between each existing hole (holes where old fasteners were just removed), from the bottom of the driver's side overhead on the roof around to passenger side.

Pre-drilling may be needed with the appropriate size bit for the screw being used.
