Service Bulletin

Subject: Seatbelt Pretensioner Harness Out of Position, Airbag Indicator Light ON, DTCs Set

Brand:	Model:	Model Year:		VIN:		Engine:	Transmission:
		from	to	from	to		
Chevrolet	Impala	2009	2010			All	All

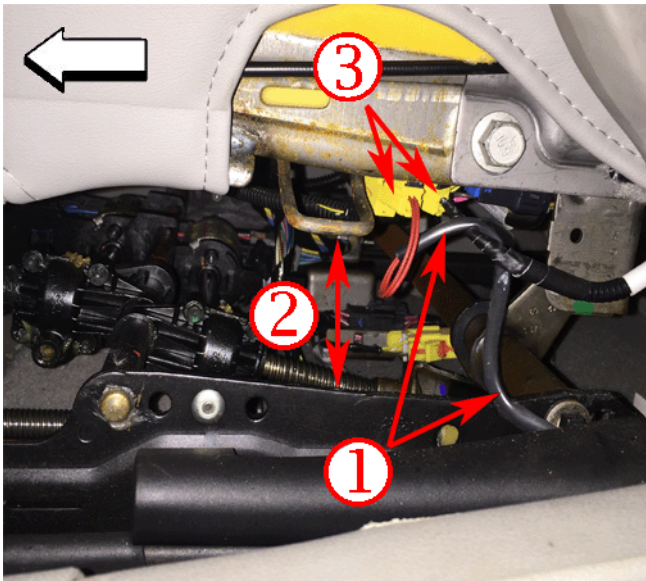
4. Inspect the seatbelt pretensioner harness for damage. (Harness (1) shown correctly looped and secured rearward, away from pinch points (2), harness connectors (3) located next to cushion).
 - If no damage found, route, or loop and secure the harness to the Side Impact Air Bag (SIAB) harness located at the rearmost part of the seat frame.
 - If harness is damaged or cut, depending on the location of the damage, replace the seatbelt pretensioner assembly or the seat harness. **Do not repair harness.** Refer to the Seat Belt Retractor Pretensioner Replacement - Front in SI. Refer to the Electronic Parts Catalog (EPC) using vehicle VIN information for correct part numbers.

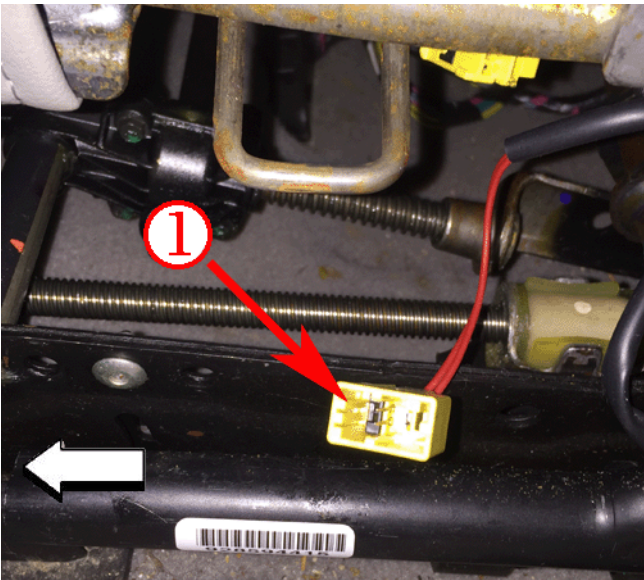
6. Inspect the connectors (1) for bent or misaligned pins or corrosion.

- If no issues found, apply dielectric grease, using an acid brush or suitable tool, to both male and female ends of the connectors and reconnect.
- If connector pins are bent, corroded or damaged, replace or perform wiring repair. Refer to Connector Repairs in SI.
