Subject: 49 CFR Part 579.5 Monthly Communications – February 2016

**INDEX OF SERVICE BULLETINS,
NOTICES, AND COMMUNICATIONS TO DEALERS**

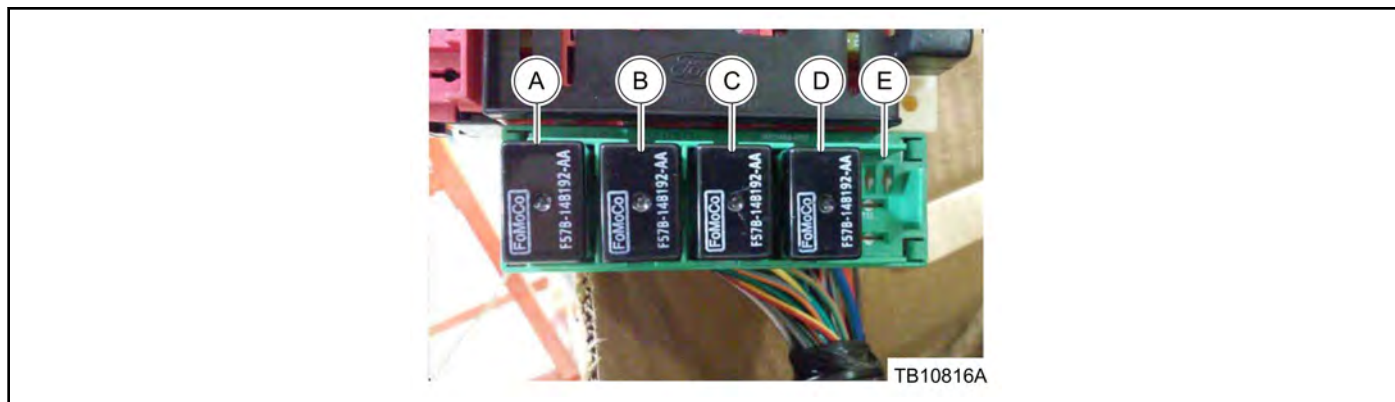
Figure 1 - Article 16-0014

Some 2011-2015 F-59 Commercial Stripped Chassis vehicles built on or before 5/29/2015 may experience hazard lighting, turn signal operation or trailer tow (TT) lighting that is not functioning properly. Vehicle vibrations may internally damage the relays that control the lighting circuits.

1. Is the hazard lighting, turn signal operation or TT lighting not functioning properly?
 - a. Yes - proceed to step 2.
 - b. No - this article does not apply. Refer to Workshop Manual (WSM), Section 417-01 for normal diagnostics.
2. Locate the central junction box (CJB) in the lower left side of dash. Remove and discard the following relays: (Figure 1)

- A - Trailer Tow Right Turn
 - B - Trailer Tow Left Turn
 - C - Right Turn
 - D - Left Turn
 - E - Empty
3. Install new 4-terminal relays in the CJB in positions A, B, C and D. (Figure 1)

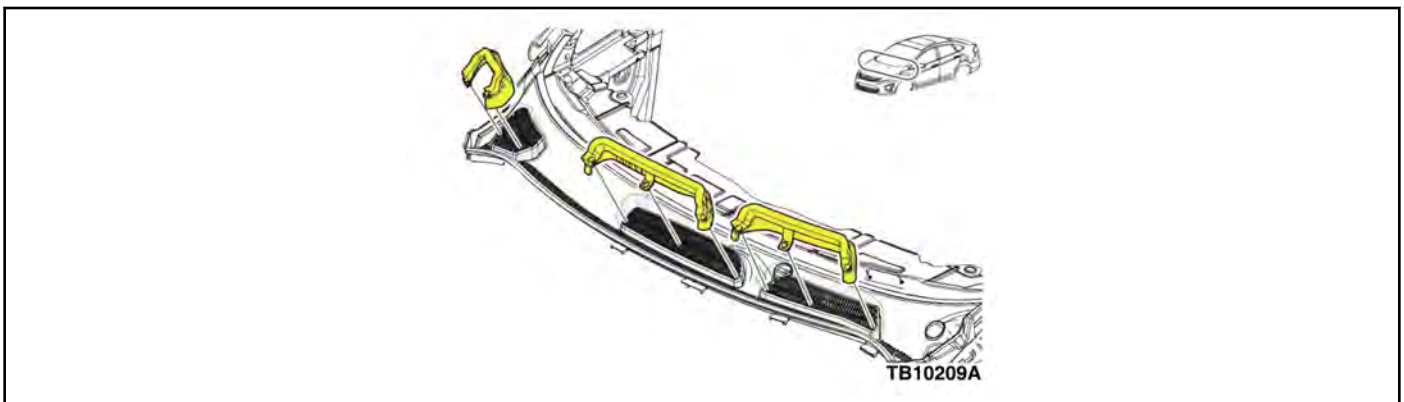
Figure 1 - Article 16-0018

Some 2011-2016 Fiesta vehicles may exhibit a lack of heat resulting from a frozen blower motor. This may be caused by snow entering through the cowl panel grille and prior screen assemblies. Snow may melt in the heating, ventilation and air conditioning (HVAC) case allowing water to enter the blower motor and freeze during a below freezing overnight soak. The blower motor fuse at location F4 in the power distribution box may also be open and the cabin air filter may be water saturated.

1. 1. Does the vehicle have an engine block heater and heated seats?
 - a. No - proceed to Step 2.
 - b. Yes - refer to Refer to Workshop Manual (WSM), Section 412-00 for normal diagnostics.
2. Replace the cabin air filter. Refer to Workshop Manual (WSM), Section 412-00.
3. Open the hood and inspect for the presence of foam deflectors on the air inlet openings of the cowl opening grille. Are deflectors present? (Figure 1).

- a. No - proceed to Step 4.
 - b. Yes - remove and discard the foam deflectors. Proceed to Step 4.
4. Remove the cowl panel grille. Refer to WSM, Section 501-02.
5. Remove all previous level screen assemblies from the bulkhead.
6. Install the new screen assembly. (Figure 2)

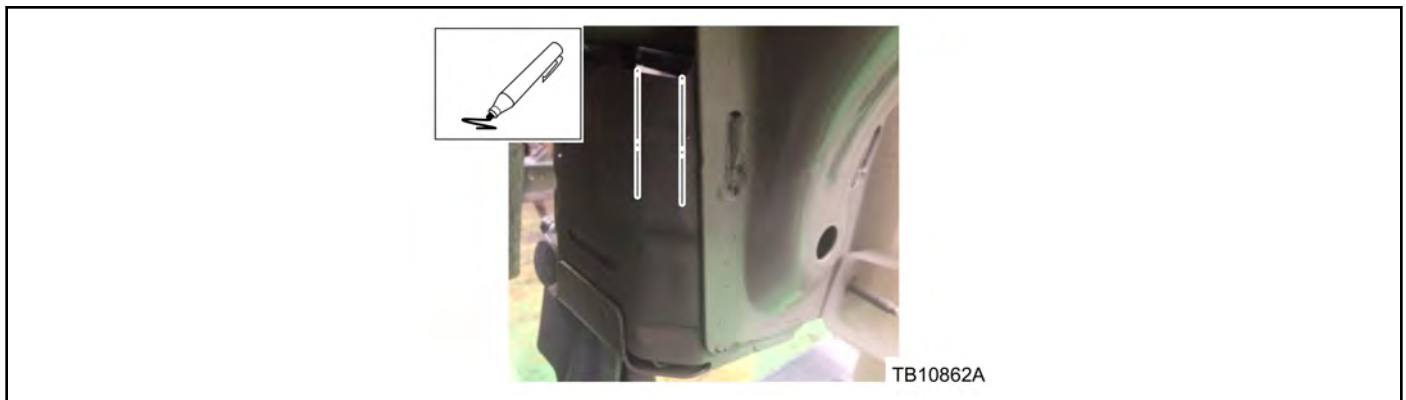
Figure 1 - Article 16-0021

The steps below will add an additional weld to eliminate the possibility of the barrel nut creak/pop noise.

1. Attach Rotunda Wireless Chassis Ears JSP97202 or equivalent. Does diagnosis with chassis ears indicate the noise is originating from the right front mounting bolt of the front subframe?
 - a. Yes - proceed to Step 2.
 - b. No - this article does not apply. Refer to Workshop Manual (WSM), Section 100-04 for normal diagnostics.
2. Disconnect the negative battery cable. Refer to WSM, Section 414-01.
3. Remove the right front wheel and tire assembly. Refer to WSM, Section 204-04.
4. Remove the right side fender splash shield. Refer to WSM, Section 501-02.
5. Locate the front subframe bolt mounting tower bracket on the right side frame member and mark 2 cut lines approximately 63 mm (2.50 in) long as shown. (Figure 1)

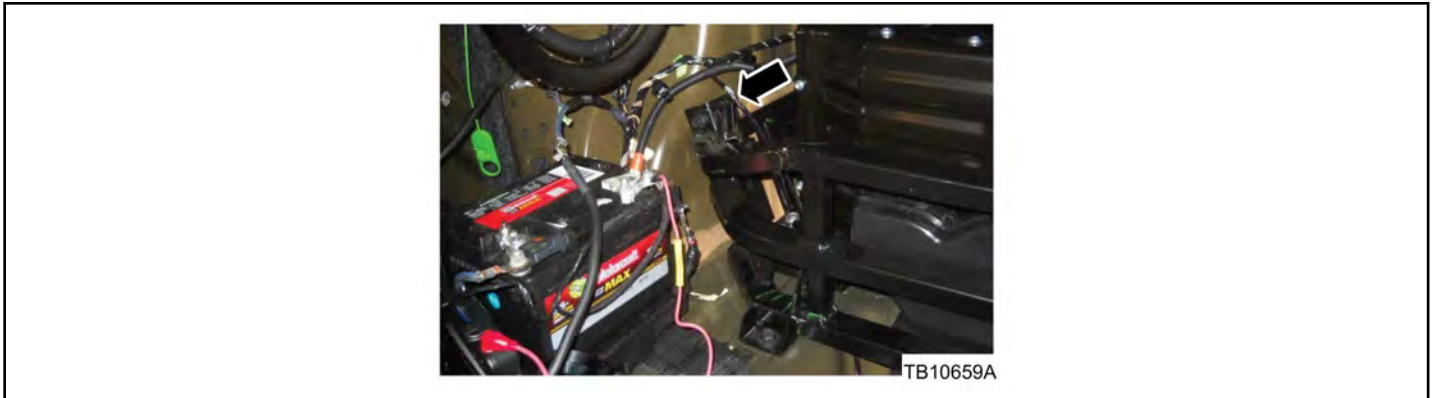
Figure 1 - Article 16-0023

4. Inspect the fan wiring from the high voltage battery pack, located at the interior left hand quarter panel, up to the fan motor(s) for damage or chafing on the metal bracket that attaches the battery cage to the vehicle body. Is chafing present? (Figure 1)

- a. Yes - repair the circuits as needed. Refer to Wiring Diagram, Section 5-1. After the repair, wrap the affected area with 3M™ Temflex™ Cotton Friction Tape or equivalent to prevent future concerns. Reinstall the driver's side trunk liner and battery access cover and proceed to Step 5.
 - b. No - wrap the affected area with 3M™ Temflex™ Cotton Friction Tape or equivalent to prevent future concerns. Reinstall the driver's side trunk liner and battery access cover, and proceed to Step 5.
5. Replace the Telematics Control Unit (TCU) module. Refer to WSM, Section 415-00.

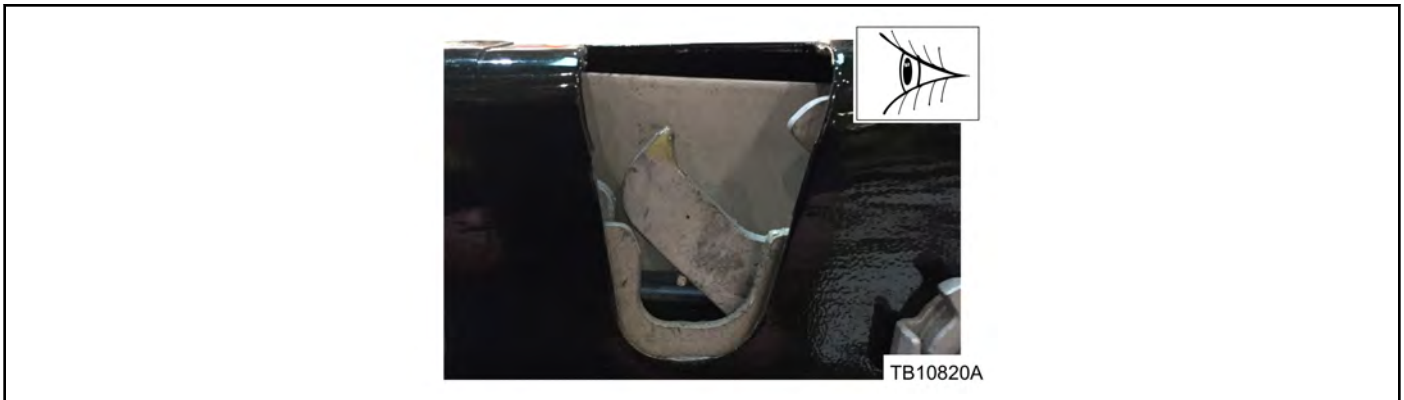
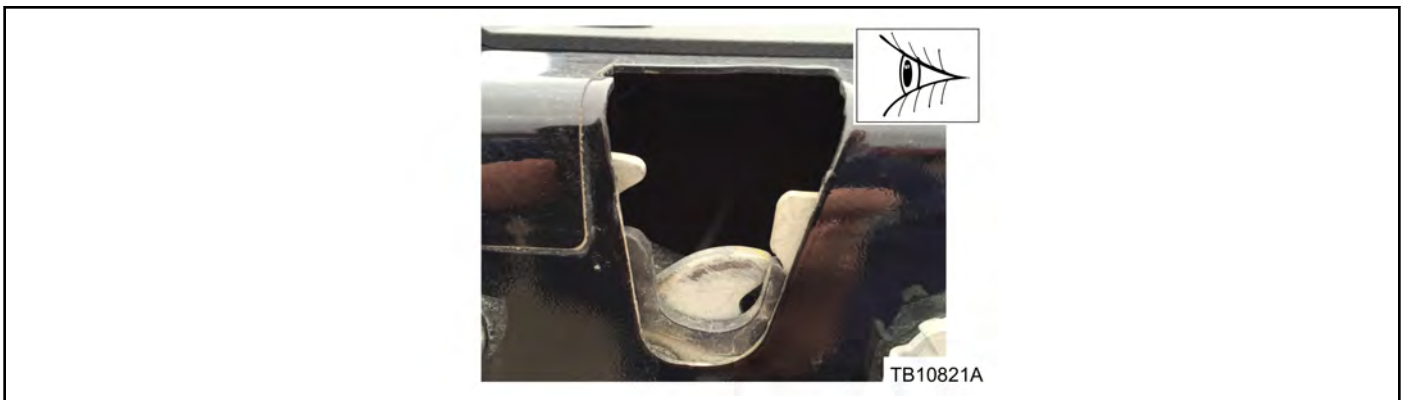
1. Inspect the left and right side tailgate latch assemblies. Is there a metal back on the inside of the latch? (Figures 1- 2)

- a. Yes - proceed to Step 6.
 - b. No - proceed to Step 2.
2. Replace the left and right tailgate latches and latch actuating rods. Refer to the Workshop Manual (WSM), Section 501-14.
