To: All U.S. and Canadian Volvo Retailers  
Subject: XC90 Courtesy Upgrade C10006

**XC90 Courtesy Upgrade C10006  
Model Year 2016 XC90**

**XC90 Courtesy Upgrade (C-10006)**

REF NO:  
**TJ 30991**

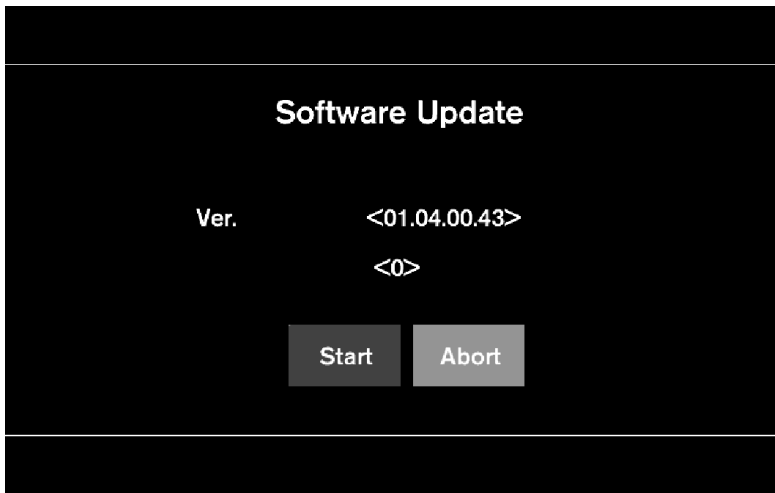
IHU stuck in engineering mode

**Note:** To speed this process up, please have someone with administrative access log into the VIDA station being used. The THD agent will need to install a special Volvo application to your machine in order to recover the IHU.

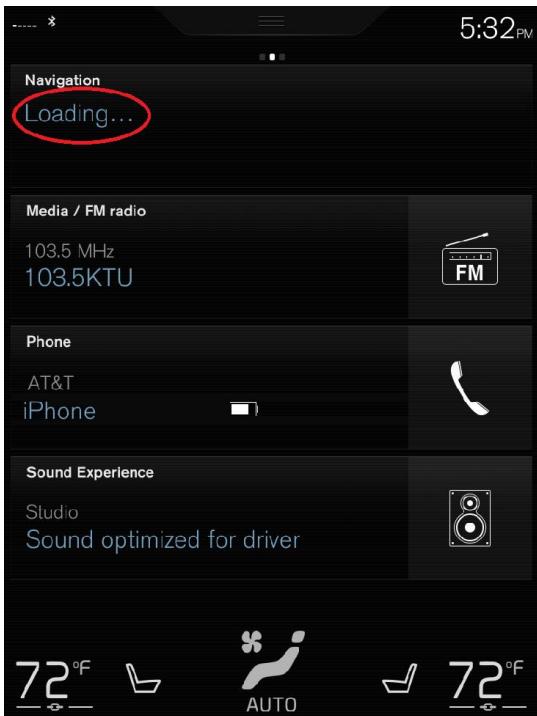
Nav stuck in map loading state
