Subject: RUST ON UNDERCARRIAGE	Bulletin No: 00-004/15
	Last Issued: 11/17/2015

2015 Mazda3 (Mexico built) vehicles with VINs starting with 3MZ (see attached VIN list)

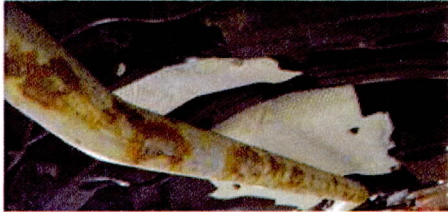
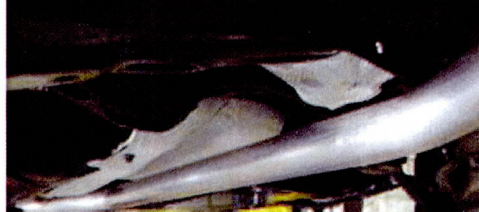
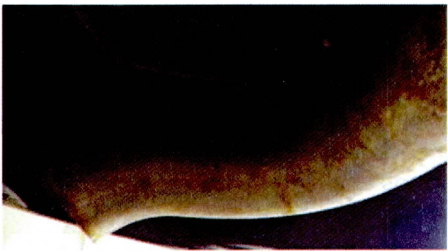
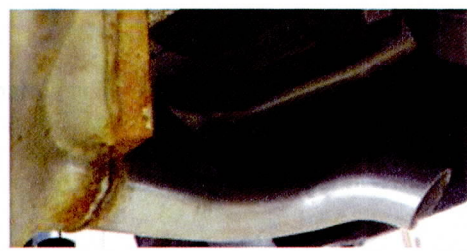
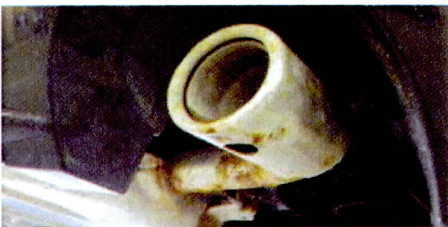
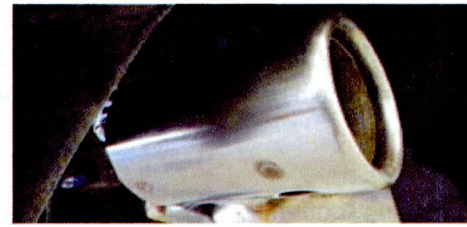
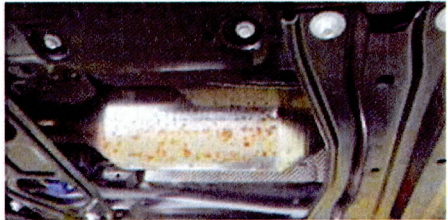
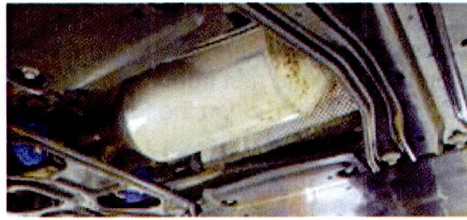
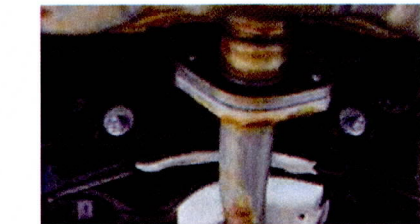
Some vehicles that were held in Port Veracruz may exhibit surface rust on the undercarriage. Port Veracruz is at the southern part of Mexico, facing the Gulf of Mexico. This area is known for very harsh environmental conditions such as extremely hot conditions, acid rain, strong winds and heavy rainfall. The combination of these natural elements can result in surface rust to the exterior chrome moldings and metal undercarriage components.

1. Verify customer concern and confirm that customer's vehicle is on the attached VIN list.
2. Raise vehicle completely in air to clean and seal undercarriage
3. Using a semi-rough scrub pad, remove any surface rust/rust from the entire (top, bottom and sides) exhaust system. Wipe the exhaust with clean paper towel. If the vehicle is equipped with chrome exhaust tip(s), use a soft/fine scrub pad and remove the rust from them. Using the same pad, clean any rust from inside the exhaust tip. Using a large wire brush, clean the flange between the rear silencer and the front exhaust pipe.

NOTE: DO NOT use Rust Fix on the exhaust system.
