<b>Subject:</b>  NOISE FROM FUEL TANK INSULATOR	<b>Bulletin No:</b> 01-010/15
	<b>Last Issued:</b> 12/14/2015

2010-2015 CX-9 vehicles with VINs lower than JM3TB\*\*\*\*\*460027 (produced before April 1, 2015)

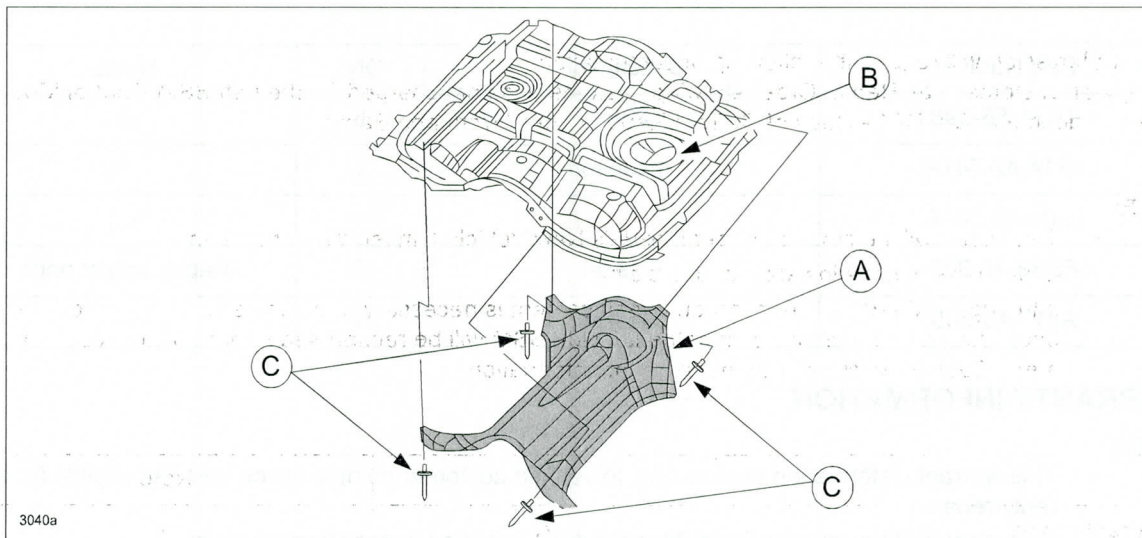
Some vehicles may exhibit an unusual noise while driving the vehicle. The noise may be caused by a broken fuel tank (B) insulator (A) that is hanging down and contacting the propeller shaft.

The rivets (C) may break when a load occurs. The rivet material has been changed to eliminate this concern. Customers having this concern should have their vehicle repaired using the following repair procedure.

1. Verify the customer concern.
2. Safely raise the vehicle on a hoist, then inspect the insulator for damaged at the rivet(s).
3. Remove the pre-silencer from the vehicle according to the instructions on MS3 online or the Workshop Manual (section 01-15 EXHAUST SYSTEM REMOVAL/INSTALLATION [MZI-3.7]).  
**NOTE:** (4WD Only): Disconnect the propeller shaft from the differential.
4. Remove and discard the insulator from the fuel tank.  
**CAUTION:** When removing the rivet pins using a drill, pay close attention not to damage the fuel tank.
5. Install the new insulator with modified rivets.
6. Re-install the pre-silencer according to the instructions on MS3 online or the Workshop Manual (section 01-15 EXHAUST SYSTEM REMOVAL/INSTALLATION [MZI-3.7]).  
**NOTE:** (4WD Only): Re-connect the propeller shaft to the differential.
7. Verify the repair.
