Subject: UNUSUAL RATTLE / BUZZ TYPE NOISE FROM PRE-SILENCER	Bulletin No: 01-024/15
	Last Issued: 12/14/2015

2010-2015 CX-9

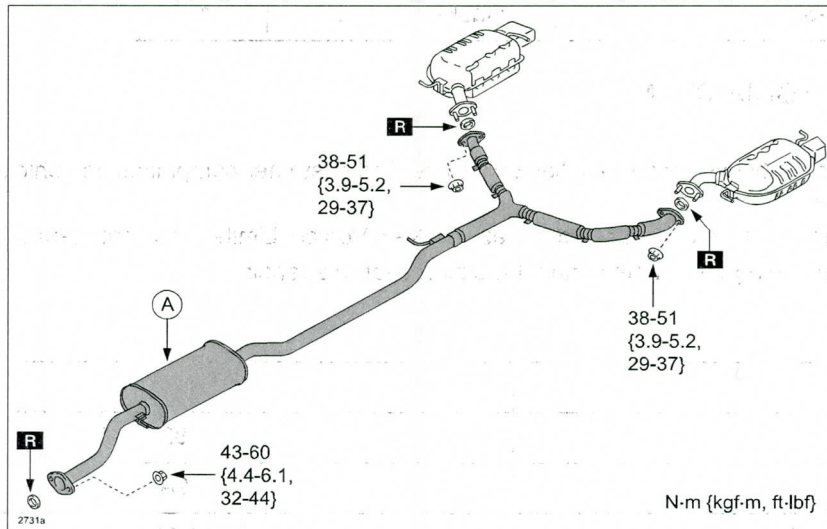
Some vehicles may exhibit an unusual rattle/buzzing type noise from the presilencer when driving at approximately 1800 rpm. The lower (rear-side) of the pre-silencer may be thermally deformed due to insufficient rigidity (fewer weld spots). The deformed portion may resonate exhaust gas pulsations, which causes noise.

A reinforced plate has been added to the pre-silencer to increase the rigidity, thereby eliminating deformation.

1. Verify customer concern.
2. Replace the presilencer (A). Refer to MS3 online or Workshop Manual (section 01-15 EXHAUST SYSTEM REMOVAL/INSTALLATION [MZI-3.7]).
