| <b>Subject:</b><br>CREAKING NOISE FROM FRONT LOWER CONTROL ARM BUSHINGS | <b>Bulletin No:</b> 02-001/15 |
| | <b>Last Issued:</b> 11/20/2015 |

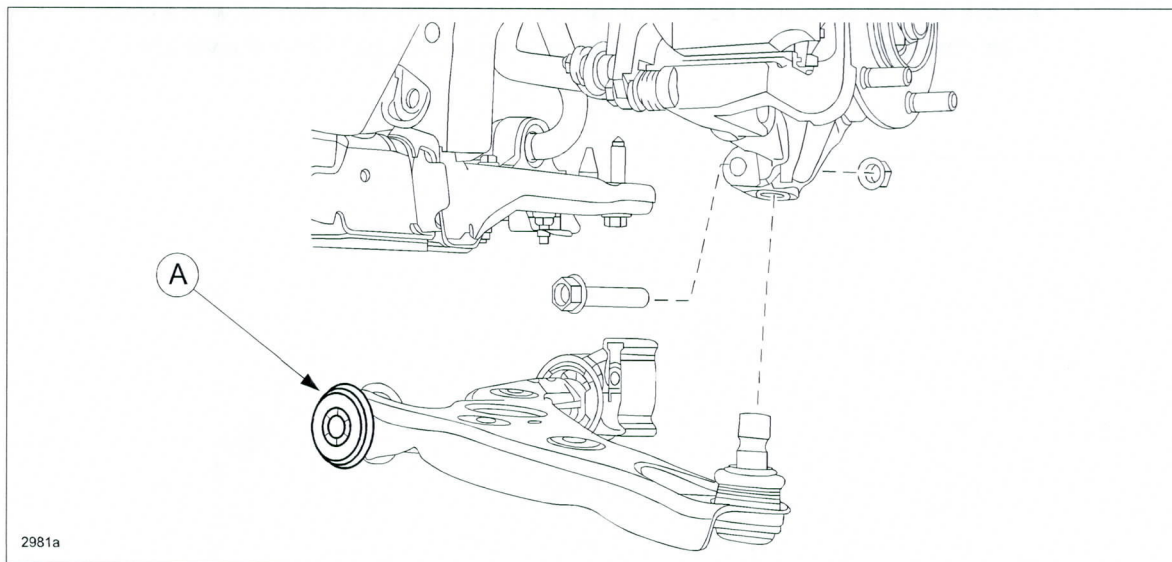
Some vehicles may exhibit a creaking noise from under the front of the vehicle when driving over bumps. The noise occurs at approx. 12 - 25 mph (20 - 40 Km/h) when the road surface is wet or after a car wash. The noise becomes more noticeable when driving over higher bumps.

The creaking noise is caused when the front lower control arm bushing(s) (A) become wet.

1. If possible, verify the customer concern when driving over bumps under wet conditions.
2. Replace front lower control arm bushing with new service part according to Steps 3 - 8.
3. Remove the front lower control arm according to the on-line instructions on MS3 or the Workshop Manual (section 02-13 FRONT LOWER ARM REMOVAL/INSTALLATION).
4. Remove the front lower arm bushing using SSTs 49 G030 797 and 49 B025 004.
5. Place the SSTs on the front lower control arm as shown below, then press out the bushing.

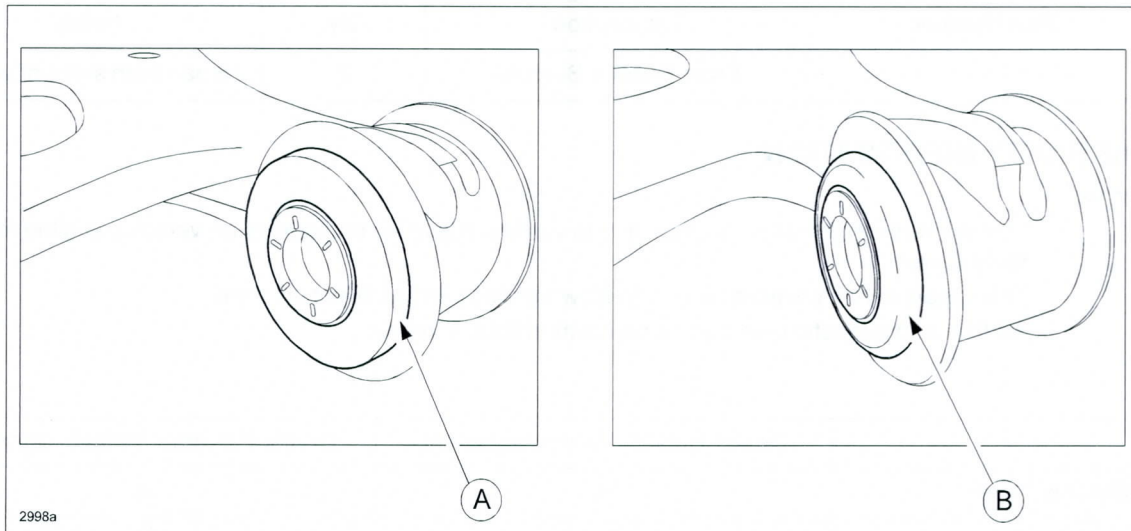
**CAUTION:** Make sure the bushing has been properly inserted by verifying that the bushing tab **IS FULLY EXPANDED**, as shown in the illustration to the left (A). The illustration to the right (B) shows an example of a bushing tab that **IS NOT FULLY EXPANDED**.
