Subject: TPMS WARNING LIGHT ON	Bulletin No: 02-002/15
	Last Issued: 11/03/2015

BULLETIN NOTE

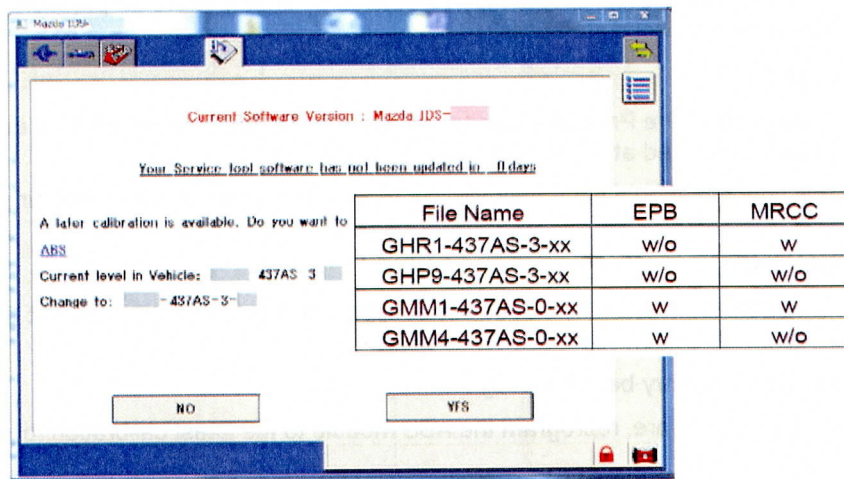
If the message "No later calibration is available on the system for this ABS" is displayed, the ABS module is already at the latest calibration. "Current level in Vehicle" will show the new file name. This service bulletin does not apply.

- b. The following screen will be displayed:
Click "YES" and follow the M-MDS instructions to reprogram the ABS module.

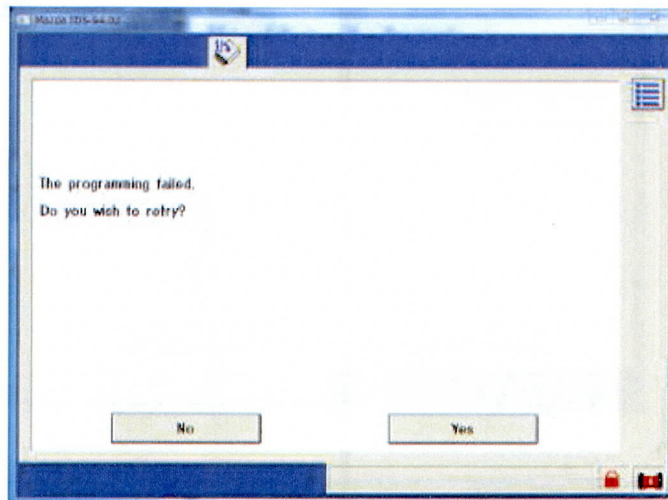
- a. If the screen shows "The programming failed. Do you wish to retry?" with Yes/No buttons, DO NOT Click the buttons and proceed to "**Recovery**" below.

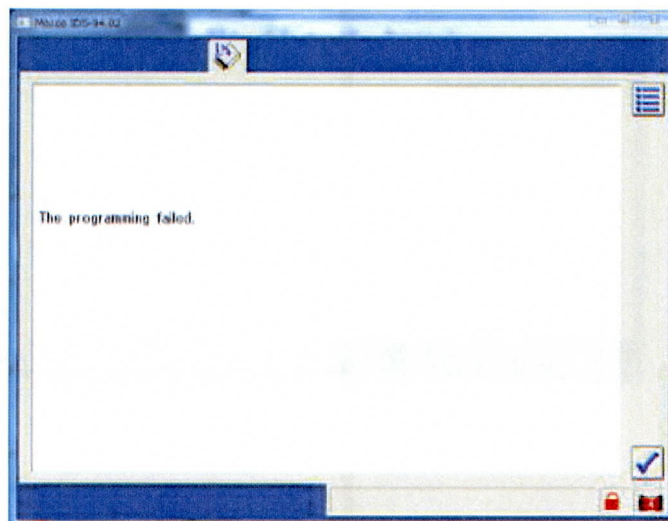
- b. If the screen shows "The programming failed." without Yes/No buttons, the ABS module has to be replaced with new one.
