Subject: MAZDA SERVICE PROGRAM (MSP45) – TIRE PRESSURE MONITORING SYSTEM WARNING LIGHT	Bulletin No: 02-006/15
	Last Issued: 11/03/2015

2014 - 2015 Mazda6 vehicles built from October 26, 2012 through November 26, 2014

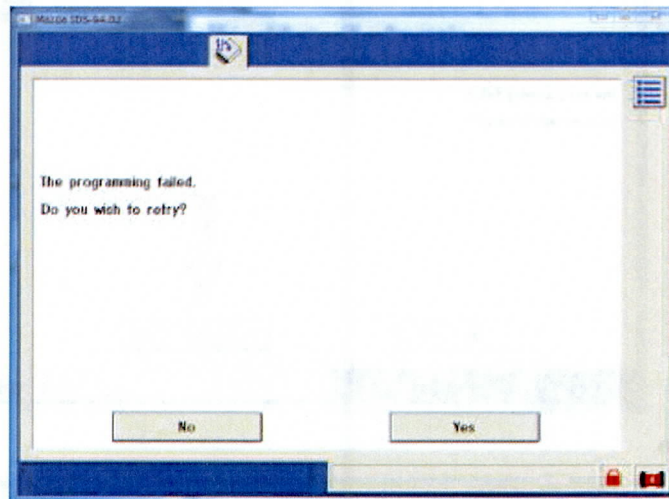
- a. If the screen shows "The programming failed. Do you wish to retry?" with Yes/No buttons, DO NOT Click the buttons and proceed to "**Recovery**" below.

Recovery

- a. Turn IG off. (If needed, press and hold the start button.)
- b. Remove the ABS/DSC 30A fuse for 10 seconds.
- c. Install the fuse and turn IG ON.
- d. Click "Yes" button and follow the on-screen instruction.

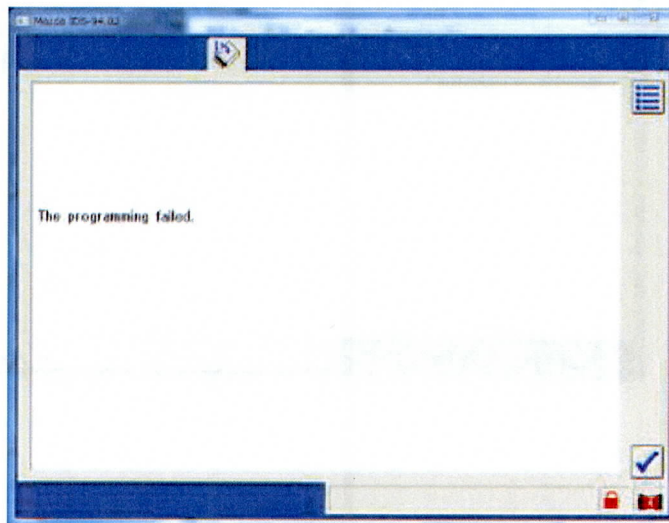
- b. If the screen shows "The programming failed." without Yes/No buttons, the ABS module has to be replaced with new one.
