Subject: AIR TEMPERATURE WILL NOT CHANGE	Bulletin No: 07-003/15
	Last Issued: 11/17/2015

APPLICABLE MODEL(S)/VINS

DESCRIPTION

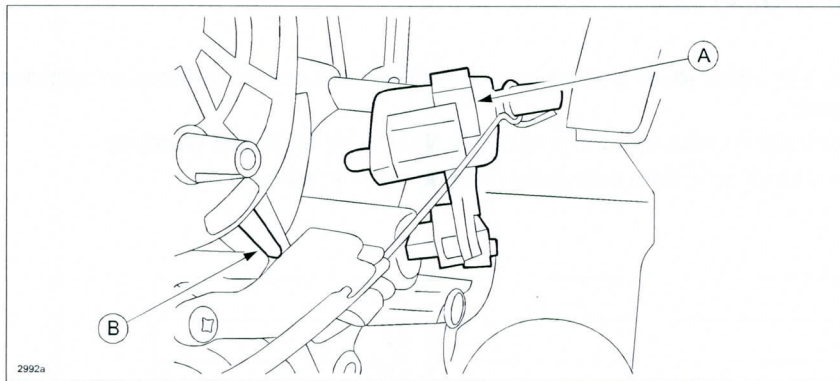
1. Verify customer concern.
2. Refer to the instructions on MS3 online or the Workshop Manual (section 07-40 CLIMATE CONTROL UNIT REMOVAL/INSTALLATION [MANUAL AIR CONDITIONER]) and check that the MIX LINK (Air mix link/Temperature control link) (A) is properly connected to the MIX DOOR CRANK (B) and works while rotating the temperature control knob.
