© 2015 Mazda Motor of America, Inc.

<b>Subject:</b>  REAR CONSOLE LID IS LOOSE	<b>Bulletin No:</b> 09-023/15
	<b>Last Issued:</b> 12/14/2015

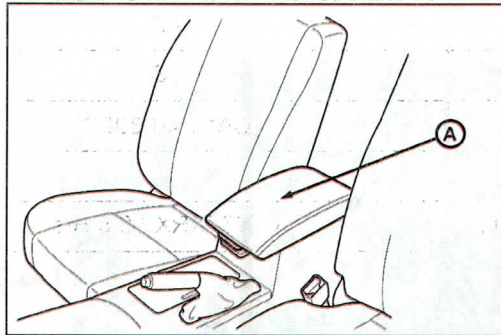
Some customers may complain about a loose rear console lid (A).

Customers having this concern should have their vehicle repaired using the following repair procedure.

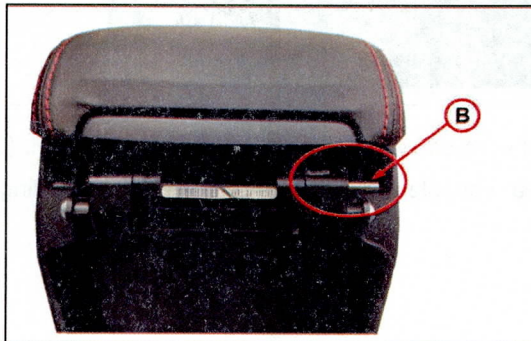
This may be caused by hinge pins coming partially off (B) or completely off.

**NOTE:** The shape of the rear console panel has been changed, by adding a stopper rib to prevent the pin from coming off.
