Subject: RATTLE / POP NOISE FROM INSTRUMENT PANEL AND/OR CREAK NOISE FROM A-PILLAR OVER ROUGH / BUMPY ROADS	Bulletin No: 09-043/15
	Last Issued: 11/09/2015

2013-2015 CX-5 vehicles with VINs of JM3KE*****514170 or lower (produced before July 31, 2014)

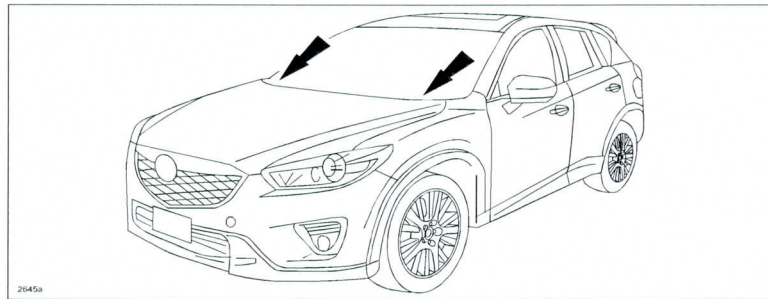
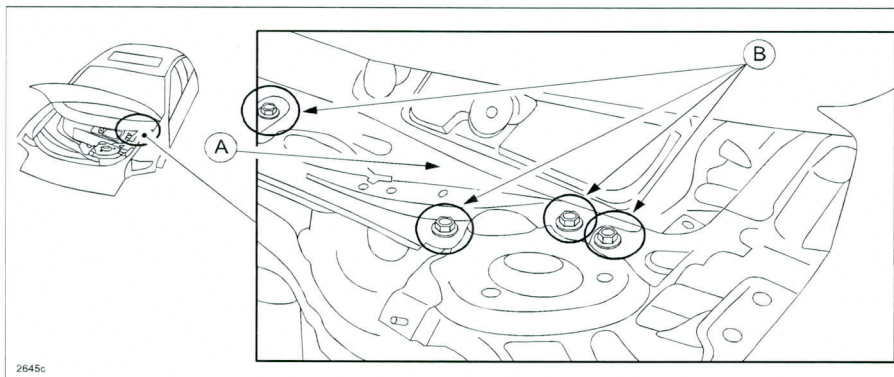
Rattle / Pop Noise From Instrument Panel:

The rattle / pop noise may be caused by low cowl panel (A) mounting bolt (B) torque.

2. Retighten all ten (10) cowl panel bolts (A) to:
Tightening Torque: 17-22 ft. lbs {22-30 Nm, 2.3-3.0 kgf-m}
3. Reinstall the cowl grille according to the online MS3 instructions or the Workshop Manual (section 09-16 COWL GRILLE REMOVAL/INSTALLATION).

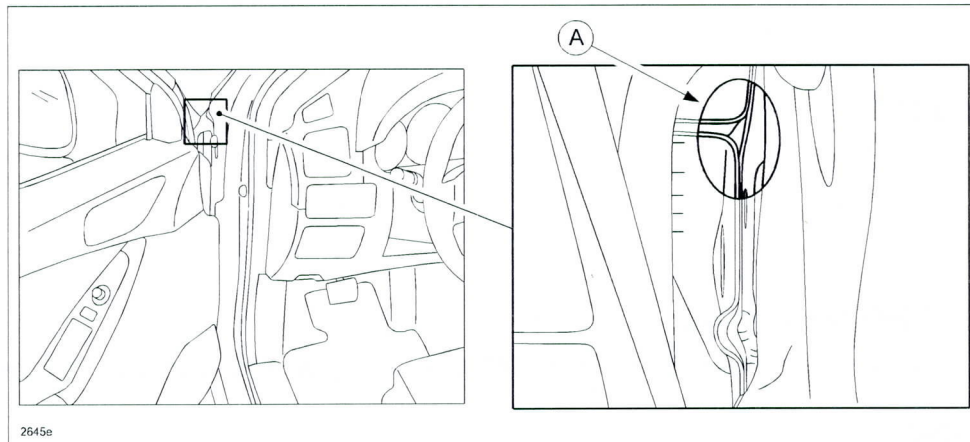
Creak Noise From A-Pillar:

This noise may be caused by two joined panels (A) scraping together at the A-pillar. The panel weld areas have been improved during the mass-production of vehicles with VINs JM3KE*****128359 (produced June 1, 2012) or higher.

Enlarge the clearance between two (2) panels (A) using an appropriate tool (i.e. flat-blade screwdriver).
