<b>Subject:</b> RATTLE NOISE FROM HEADER PANEL OF CONVERTIBLE TOP	<b>Bulletin No:</b> 09-045/15
	<b>Last Issued:</b> 12/23/2015

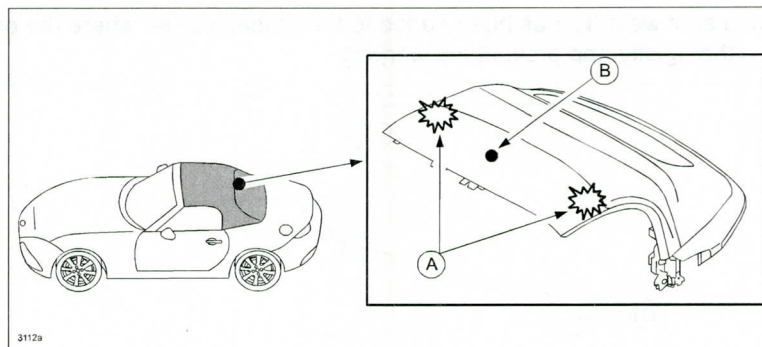
Some vehicles may exhibit a rattle noise (A) from the header panel (B) of the convertible top when driving on a rough road.

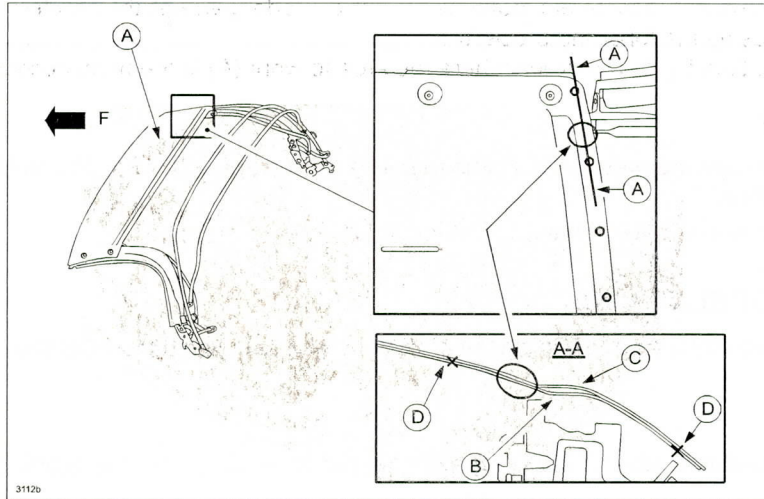
The header panel (A) is formed by two aluminum panels, inner (B) and outer (C). When receiving an input force by driving on a rough road, the two panels at the problem area, where spot welds are located (D), may warp and change relative position causing the rattling noise. (F=Front)
