Subject: RATTLE NOISE FROM HEADER PANEL OF CONVERTIBLE TOP	Bulletin No: 09-045/15
	Last Issued: 12/04/2015

2016 MX-5 vehicles with VINs lower than JM1ND*****107384 (produced before October 26, 2015)

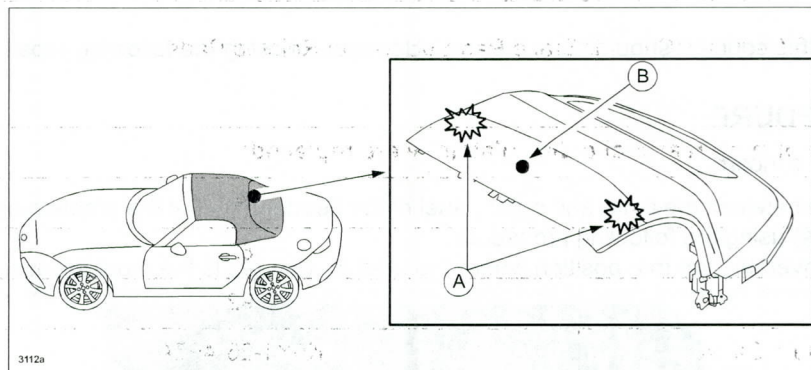
Some vehicles may exhibit a rattle noise (A) from the header panel (B) of the convertible top when driving on a rough road.

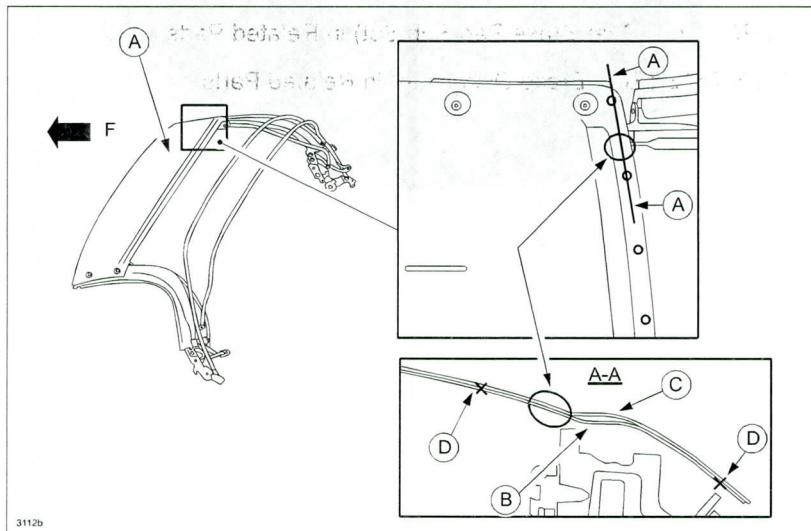
The header panel (A) is formed by two aluminum panels, inner (B) and outer (C). When receiving an input force by driving on a rough road, the two panels at the problem area, where spot welds are located (D), may warp and change relative position causing the rattling noise. (F=Front)
