Service Bulletin

Subject: 2013-2014 CX-5 - VARIOUS ELECTRICAL SYSTEM MALFUNCTION(S) RELATED TO C-15 CONNECTOR CORROSION	Bulletin No: 09-041/15
	Last Issued: 10/14/2015

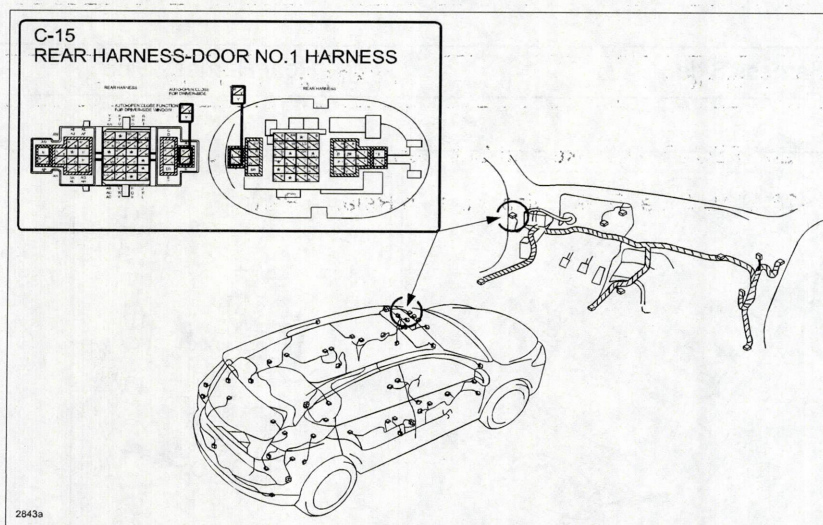
Some vehicles may experience one or more of the following symptoms in connection with a malfunction related to the C-15 connector.

- The driver side power window does not operate.
- The door does not open when using the advanced keyless system.
- The warning lamp stays ON even after the ignition switch is turned OFF.
- DTC B10E7:17 (START STOP UNIT, IG1 Relay Circuit Malfunction) and DTCs related to communication errors may be stored in PCM memory.

The symptoms listed above may be caused by corrosion of the C-15 connector terminals due to water intrusion through the front door. In low ambient temperatures, the door harness hardens. If the door is fully opened, it may create a gap between the door and the door harness grommet, which may allow water to enter through the gap.

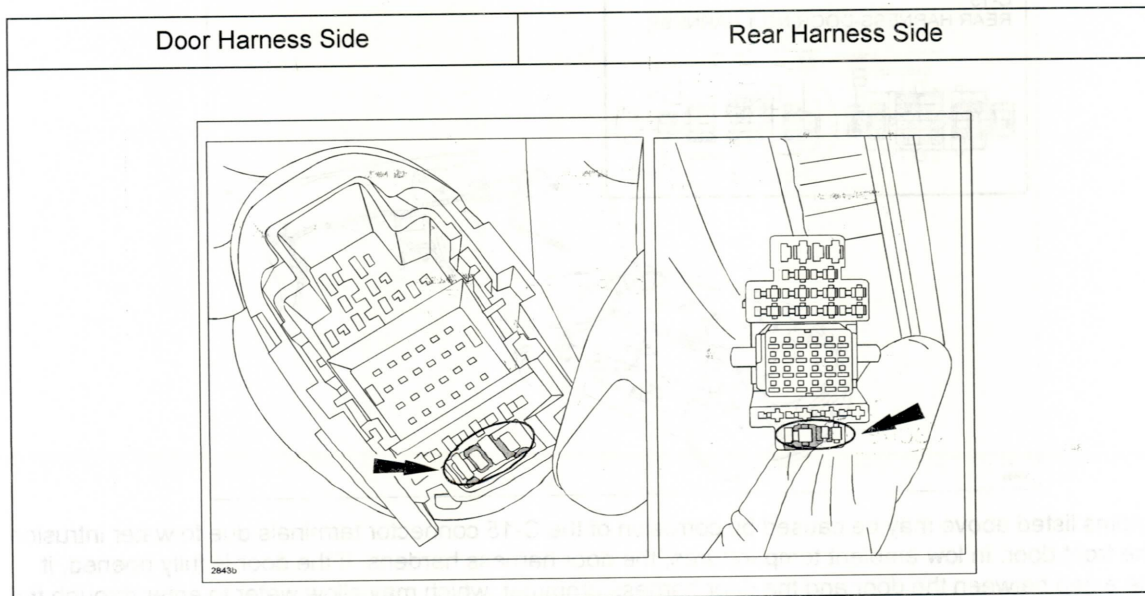
- If there is any corrosion found on the terminals, go to next step.
- If there is no corrosion found on the terminals, this bulletin is not applicable. Troubleshoot the concern(s) according to the MS3 online instructions or the Workshop Manual.

- If there is any corrosion at the C-15 connector, replace the door harness and repair the rear harness according to the following repair procedure.
 - If there is no corrosion found at the C-15 connector, this bulletin is not applicable. Troubleshoot the concern(s) according to the MS3 online instructions or the Workshop Manual.
1. Verify the customer concern.
 2. Record customers pre-set radio stations.
 3. Slide the driver side front seat fully backwards.
 4. Disconnect the negative battery cable.
 5. Disconnect the C-15 connector according to the MS3 online instructions or the Workshop Manual (section 09-11 FRONT DOOR REMOVAL/INSTALLATION).
 6. Inspect for any corrosion found on the terminals shown below.
