Service Bulletin - Technisches Rundschreiben - Circulaire Technique - Circular Tecnica

Object: **Cable relocation key switch ZADI**

Product: **F4 RC 2015**
ZCGMCFTW0FV005906
ZCGMCFTW1FV006272

- In the note of the warranty, please refer to the service bulletin n° 158

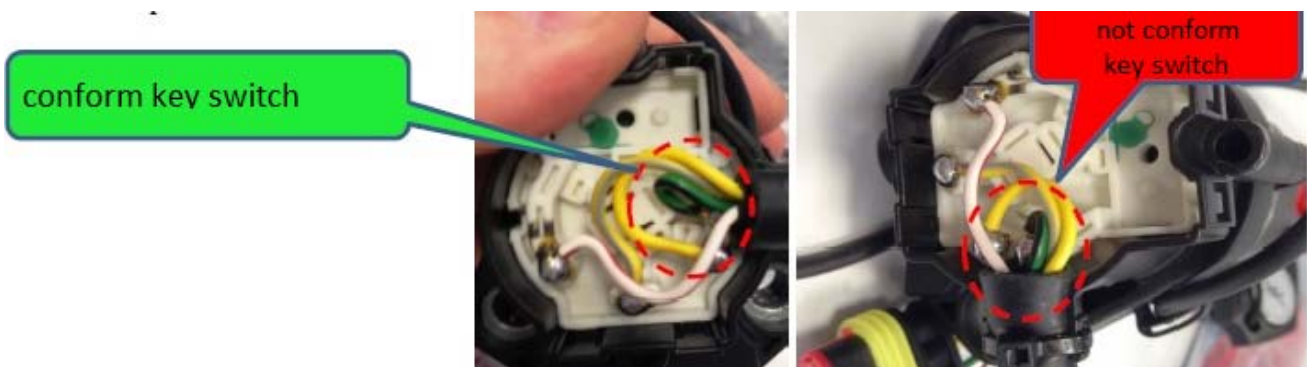
As the picture in attached.

On motorcycles involved in this service bulletin, the green/black wire in some cases is too stretched. This problem in addition to the vibrations and twists due to movement of the steering, may result in loosening or detachment of the contact in the ignition switch.
