Service Bulletin

Date: 26th May 2015

Subject: **Windshield support check**

Product: **Turismo Veloce**

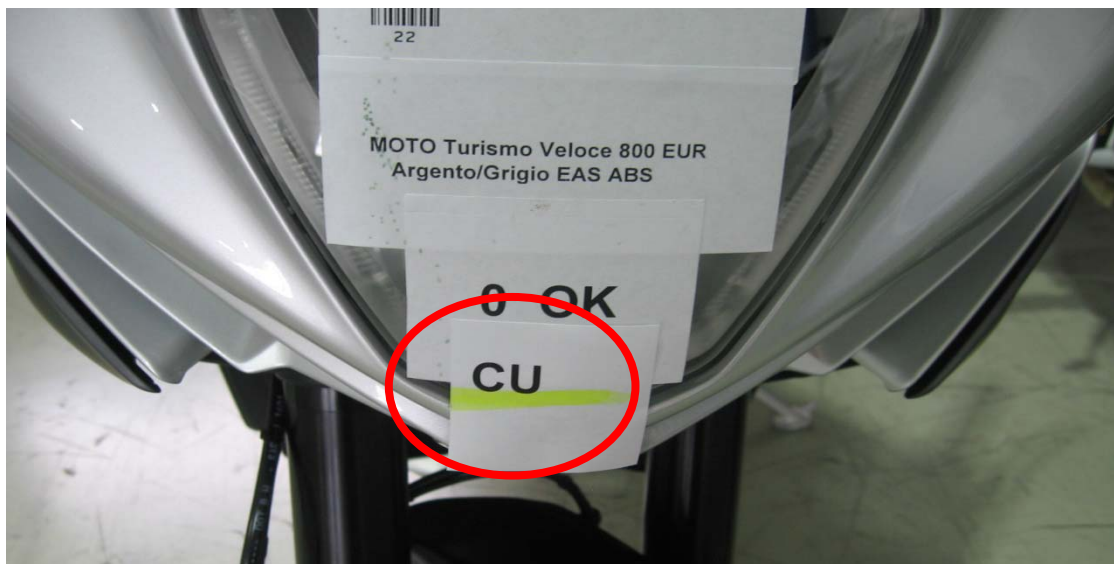
- Motorcycles with VIN included in the VIN range indicated, but tagged with the sticker "CU" as you can see in the image below, have already been updated in MV Agusta.

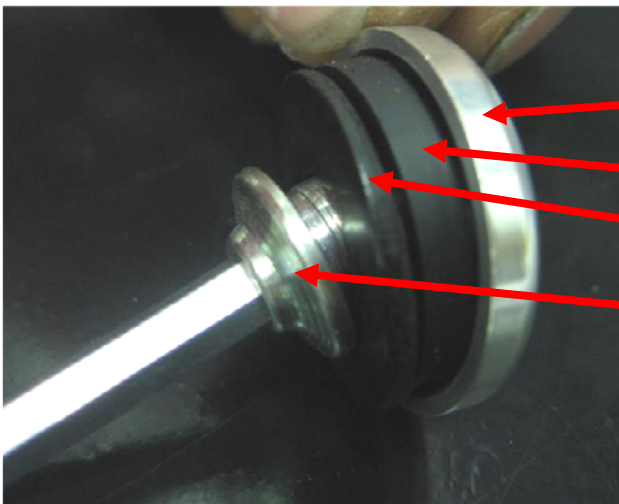
5 – take off the screw and all the elements of the internal fixing, ensure that you have followed this sequence: screw, black washer, rubber washer put in the cup.

If all the elements are present according to the indicated sequence, proceed with the assembly adding Loctite 243 on the first threads of the screw. (if one or more components are missing order the necessary spare parts to warehouse and then proceed inserting the codes in the warranty claim)
