NUMBER: 18-021-15 REV. E

Flash: 3.0L Powertrain Diagnostic And System Enhancements

2014 (DS) RAM 1500 Pickup

NOTE: This bulletin applies to vehicles equipped with a 3.0L Diesel Engine (Sales Code EXF).

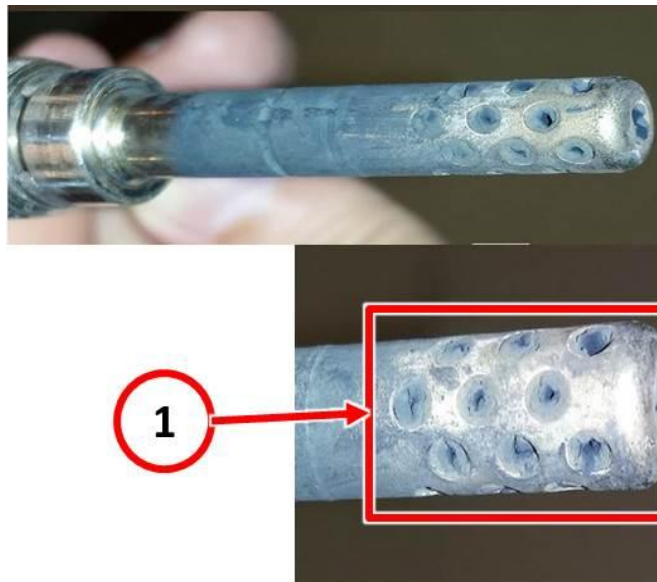
Fig. 1 EGT Sensor Bank 1 Sensor 1

11. Replace the O2 sensor. Refer to detailed repair procedures available in DealerCONNECT> TechCONNECT> Service Info Section 14 - Fuel System> Fuel Injection, Diesel> Sensor, Oxygen> Removal/Installation. Proceed to [Step #12](#).
12. Remove the EGT Sensor 1/2 located in the inlet of the Diesel Particulate Filter (DPF)/Diesel Oxidation Catalyst (DOC) assembly. Refer to detailed removal procedures available in DealerCONNECT> TechCONNECT> Service Info Section 11 - Exhaust System> Sensor, Exhaust Temperature> Removal> Exhaust Gas Temperature Sensor 1/2.
13. Inspect the sensor body and probe for any signs of damage or excessive soot. See ([Fig. 1](#)).

1 - Excessive soot blocking sensor ports

-
14. Was excessive soot found on the sensor?
 - a. Yes>>> Proceed to [Step #15](#).
 - b. No>>> Proceed to [Step #16](#).
 15. Using shop air set to a maximum of 80 psi, clean all excessive soot from the sensor probe.
 16. Using a suitable multi-meter with appropriate test probes, test the resistance between the sensor connector terminals 1 and 2. With the sensor at room temperature, 65-75 °F (18-25 °C), the resistance should measure between 200 and 240 ohms.
