NUMBER: 08-042-15

Power Wagon Splash Screen Missing In The Electronic Vehicle Information Center (EVIC)

2015 (DJ) Ram Power Wagon

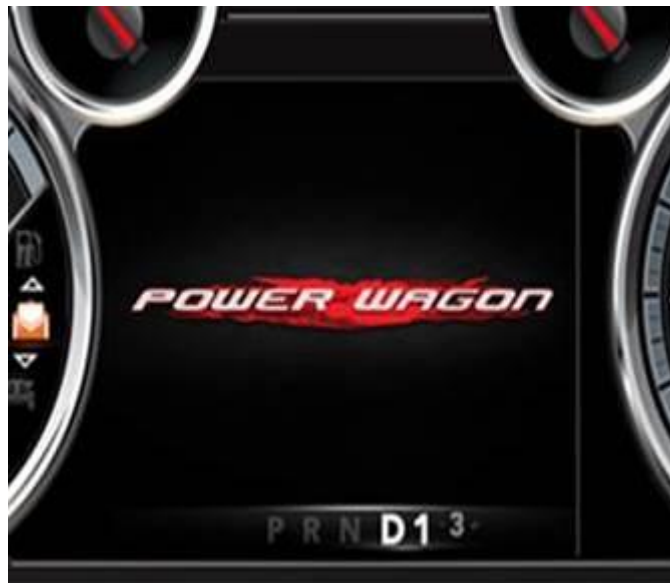
Fig. 1 Power Wagon Splash Screen

The customer may notice the Power Wagon splash screen is missing in the Electronic Vehicle Information Center (EVIC) when the vehicle is first started.

1. Using wiTECH, reconfigure the vehicle. This routine is available under the 'Diagnostic Procedures' tab found on the home, 'Vehicle View', page of wiTECH.
2. Using wiTECH clear any DTCs which may have been set during the reconfiguration.
