NUMBER: 08-059-15 REV. A

Travel Link Button Not Displayed On The Radio Screen

This bulletin involves upgrading the software on the RA4 Radio.

2016 (FB) Fiat 500X (U.S. Market Only)

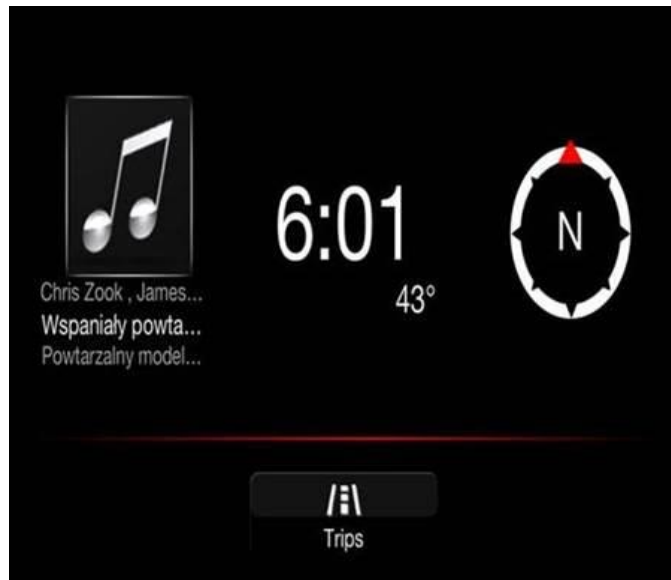
Fig. 1 Display Before Update

The customer may notice that the Sirius XM® travel link button is not displayed on the radio, see (Fig. 1).

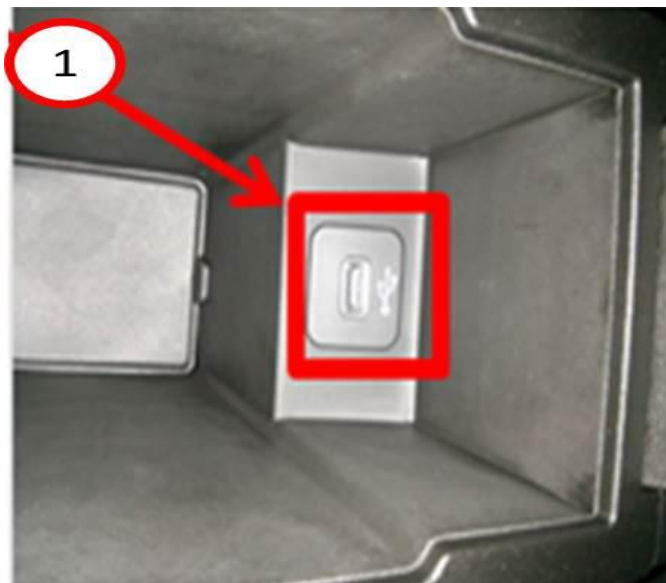
Fig. 2 Location Of USB Port

1 - USB port in center console compartment.

6. Remove any customer USB flash drive from both USB ports.
7. With the engine running and radio powered on, insert the **correct** USB flash drive into USB port in the **center armrest compartment**. see (Fig. 2).
