NUMBER: 08-059-15

Travel Link Button Not Displayed On The Radio Screen

This bulletin involves upgrading the software on the RA4 Radio.

2016 (FB) Fiat 500X (U.S. Market Only)

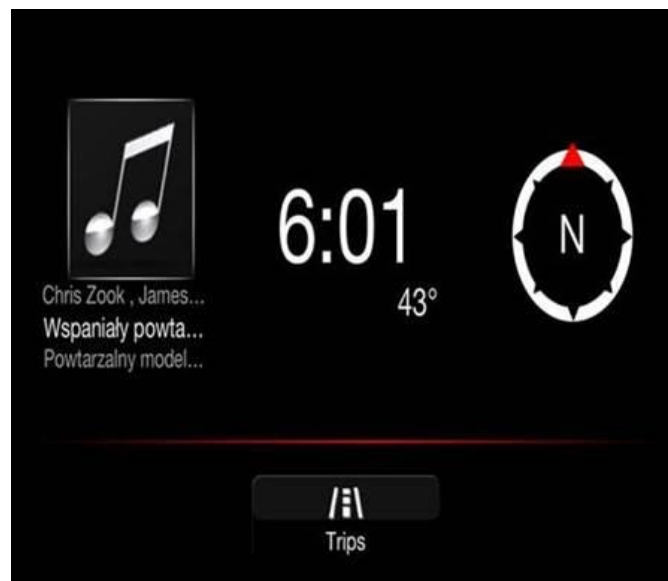
Fig. 1 Display Before Update

The customer may notice that the Sirius XM® travel link button is not displayed on the radio, see (Fig. 1).

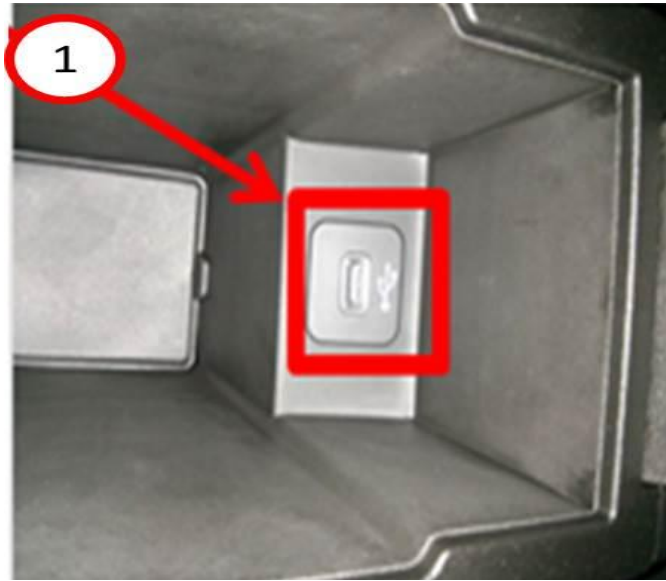
Fig. 2 Location Of USB Port

1 - USB port in center console compartment.

7. With the engine running and radio powered on, insert the **correct** USB flash drive into USB port in the **center armrest compartment**. see (Fig. 2).
