NUMBER: 18-021-15 REV. C

GROUP: Vehicle Performance

Flash: 3.0L Powertrain Diagnostic And System Enhancements

2014 (DS) RAM 1500 Pickup

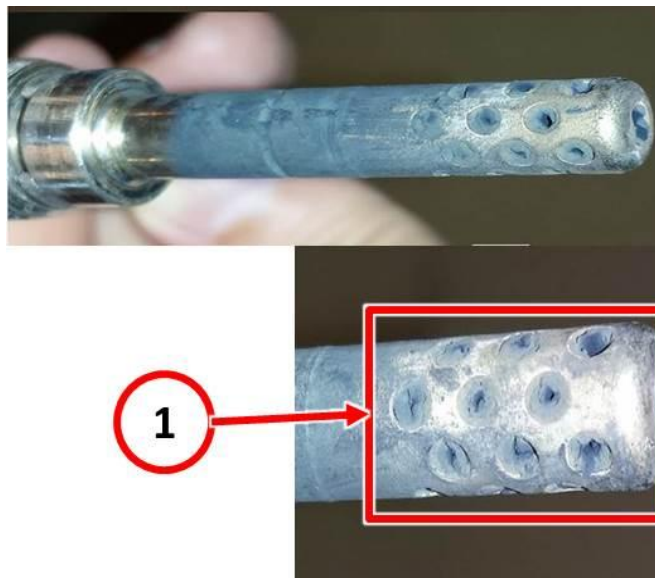
Fig. 1 EGT Sensor Bank 1 Sensor 1

7. Refer back to the codes recorded in [Step #1](#). Were DTCs, P0171-00 - Fuel System 1/1 Lean and/or P0133-00 - O2 Sensor 1/1 Slow Response found setting in the PCM memory?
 - a. Yes>>> Proceed to [Step #8](#).
 - b. No>>> The bulletin is now complete. No further action is required. Use Labor Op 18-19-04-B3 to close out the RRT portion of this service action.
8. Visually inspect all Air Induction and Charge Air Cooler (CAC) connections for proper installation and torque. Repair as necessary and proceed to [Step #9](#).

1 - Excessive soot blocking sensor ports

-
12. Was excessive soot found on the sensor?
 - a. Yes>>> Proceed to [Step #13](#).
 - b. No>>> Proceed to [Step #14](#).
 13. Using shop air set to a maximum of 80 psi, clean all excessive soot from the sensor probe.

14. Using a suitable multi-meter with appropriate test probes, test the resistance between the sensor connector terminals 1 and 2. With the sensor at room temperature, 65-75 °F (18-25 °C), the resistance should measure between 200 and 240 ohms.
15. Is the temperature sensor resistance within specifications?
 - a. Yes>>> Install the original EGT sensor 1/2. Refer to detailed installation procedures available in DealerCONNECT> TechCONNECT> Service Info Section 11 - Exhaust System> Sensor, Exhaust Temperature> Installation> Exhaust Gas Temperature Sensor 1/2.
 - b. No>>> Install a new EGT sensor 1/2. Refer to detailed installation procedures available in DealerCONNECT> TechCONNECT> Service Info Section 11 - Exhaust System> Sensor, Exhaust Temperature> Installation> Exhaust Gas Temperature Sensor 1/2.
16. Verify all engine systems are operating as designed. The bulletin is now complete.
