NUMBER: 08-017-15

SUBJECT:

No Travel Link Data Displayed And Other System Enhancements

This bulletin involves updating the radio's software if needed.

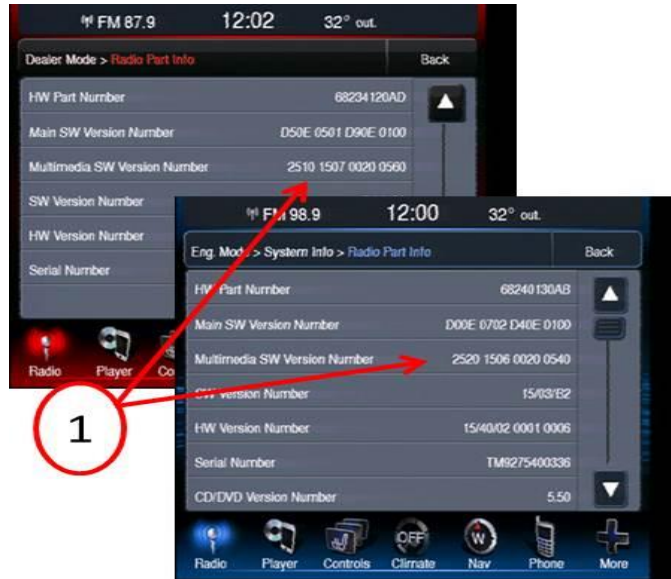
Fig. 1 Multimedia SW Version Number

5. Is the version number 2510 1507 0020 0560 or 2520 1506 0020 0540? (Fig. 1).

1 - Version Numbers

- a. Yes >>> The radio already has the updated software. Use inspection LOP (18-60-02-EK) to close active RRT. This bulletin has been completed.
- b. No >>> Proceed to [Step #6](#).

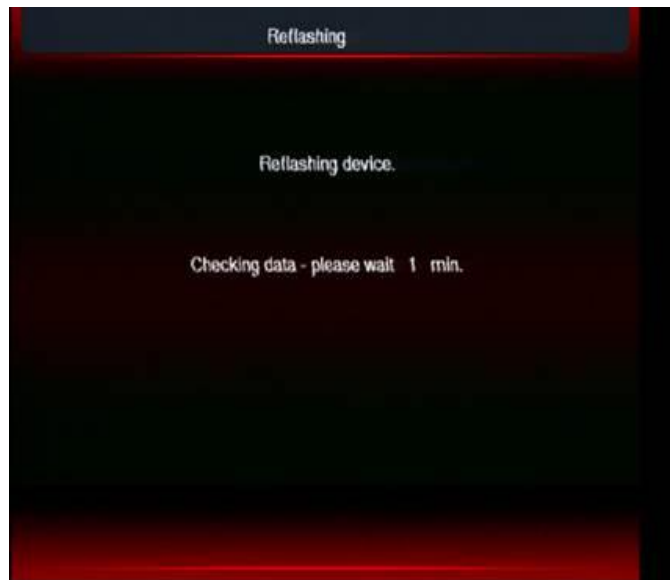
Fig. 2 Checking Data Please Wait 1 Minute

Please Wait

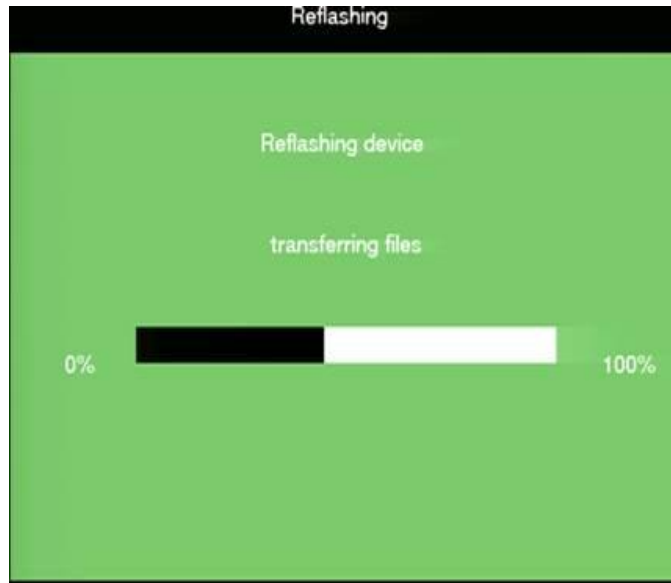
Fig. 3 Transferring Files

15. The next screen is titled "Reflashing" this part of the update will take about 8 minutes.

Please Wait

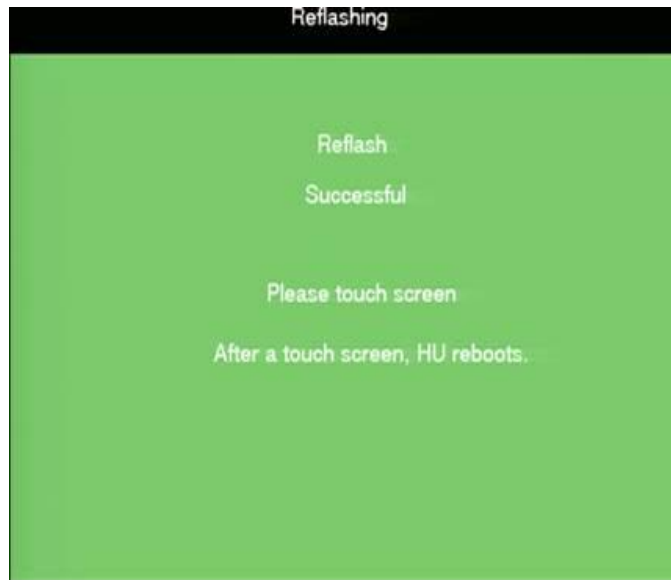
Fig. 4 Touch Screen

-
16. Once the files have been transferred, the screen will display "Successful".
 17. Touch the screen to continue the update.

Touch Screen

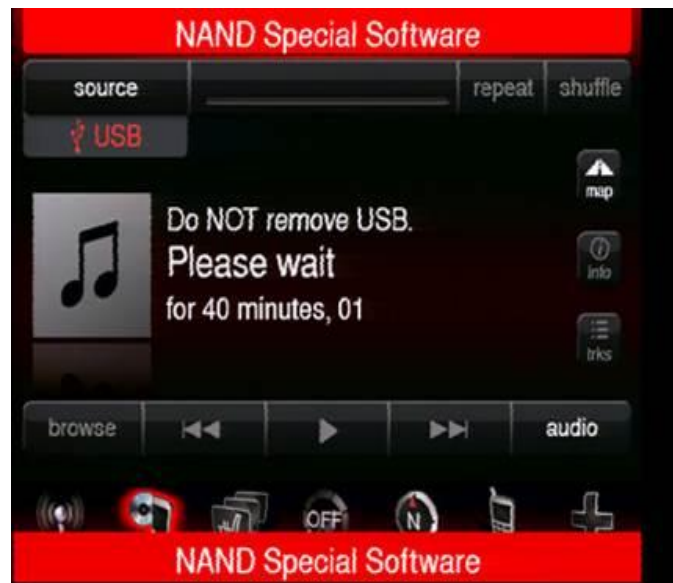
Fig. 5 NAND Special Software

-
18. The next screen will be titled NAND Special Software, this step may take 30 to 40 minutes.

May Take 30 to 40 Minutes

NOTE: During this part of the update do NOT turn off the vehicle or radio. Do NOT change any radio features.

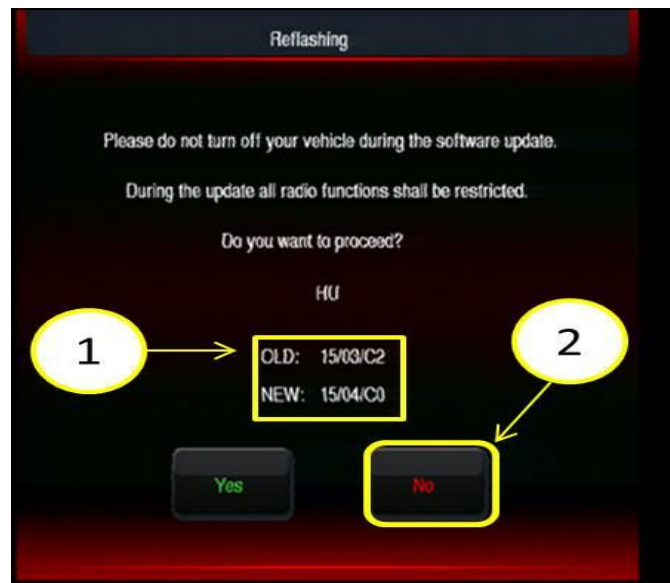
Fig. 6 When Update Is Completed Properly, New and Old Software Will NOT Match

CAUTION: The only way to properly check if the radio has been updated correctly, is checking the Multimedia SW. When the update has been completed the New and Old software version WILL NOT MATCH, (Fig. 6).

- 1 - New and Old Software Will NOT Match
- 2 - Press No to Continue

CAUTION: The only way to properly check if the radio has been updated correctly, is checking the Multimedia SW. When the update has been completed the New and Old software version WILL NOT MATCH.

20. The next screen will display the New and Old software, press **No** to complete the software update (Fig. 6).
