**NUMBER:** 18-015-15

**GROUP:** Vehicle Performance

Malfunction Indicator Lamp (MIL) Illumination And/Or Intermittent No Crank No Start

2014-2015 (DS) Ram 1500

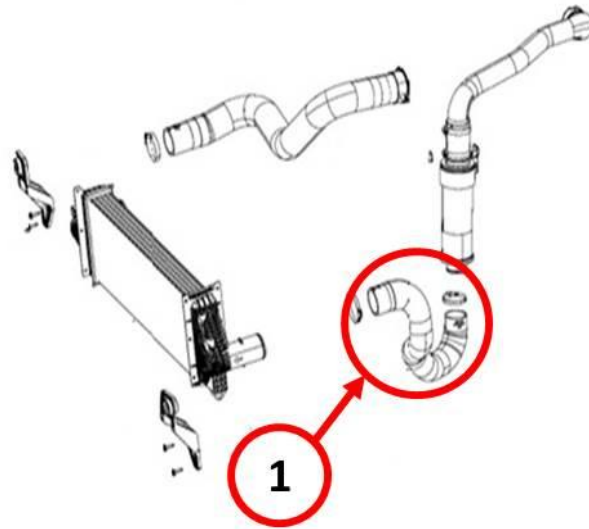
**Fig. 2 CAC System**

1 - Lower CAC hose.

- 
13. Inspect for and drain any accumulated water from the CAC hose. Dry using shop air.
  14. Was excessive moisture found in the lower CAC tube?
    - a. Yes>>> Proceed to [Step #15](#).

12. Loosen the clamps and remove the lower CAC hose from between the CAC and resonator. See ([Fig. 2](#)).
