**NUMBER:** 21-037-15

**GROUP:** Transmission and

Transmission Heater Assembly Reinforcement Plate

2015 (DS) RAM 1500 Pickup 2015 (DX) RAM 1500 Pickup (MEXICO)

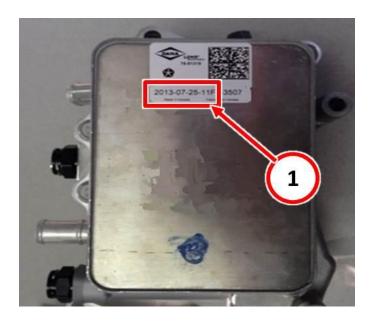
Fig. 1 Transmission Heater Assembly

1 - Build Date Label (yyyy-mm-dd)

- 3. Is the build date on the Transmission Heater Assembly between 2014-12-02 and 2014-12-09?
  - a. Yes >>> Proceed to Step #4.
  - b. No >>> This service bulletin does not apply. Further diagnosis is required including pressure testing of the Transmission Heater Assemblies outside of the build date range above.
- Replace the Transmission Heater Assembly. Refer to detailed repair procedures in DealerCONNECT/TechCONNECT Service Info Section 21 - Transmission and Transfer Case> Automatic - 8HP70/845RE> HEATER, Transmission> Removal/Installation.
