Service Campaign Bulletin

Campaign No. 2015120008, December 2015

SUBJECT: **Model 205 (C Class), Model Year 2016**
Install Rivet to Left Front Wheel Arch

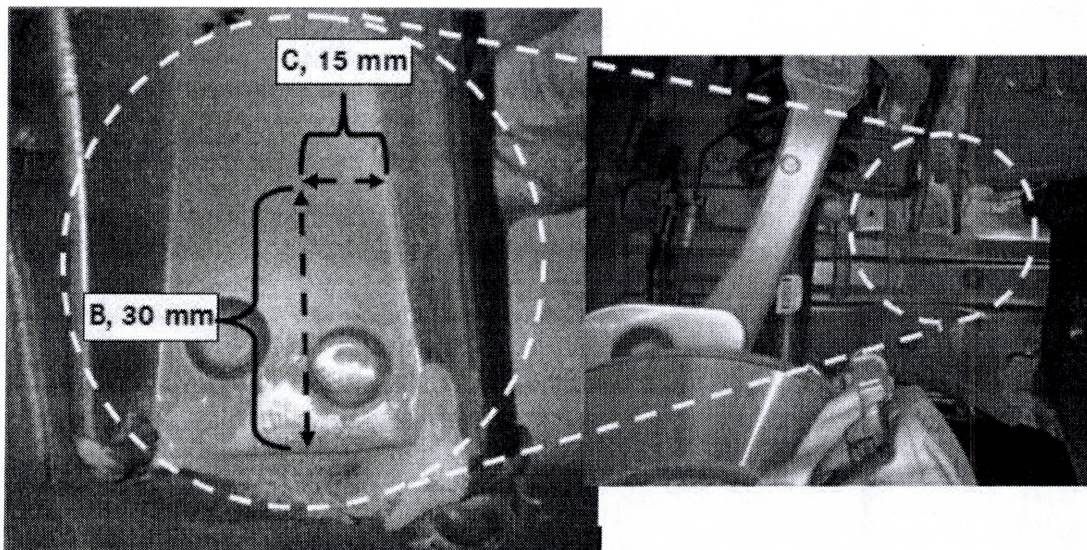
**Figure 2**

Lower edge of mounting console is concealed by sealing bead. Sealing bead **must** not be removed.

3. Make a punch mark in mounting console at left rear as shown (Figure 2):

- Dimension B: From bottom to top approx. 30 mm.
- Dimension C: From mounting console edge at right inwards approx. 15 mm.
