Service Bulletin

Bulletin No.: 15-NA-074

Subject: Seatbelt Pretensioner Harness Out of Position, Airbag Indicator Light ON, DTCs Set

Brand:	Model:	Model Year:		VIN:		Engine:	Transmission:
		from	to	from	to		
Chevrolet	Impala	2009	2010			All	All

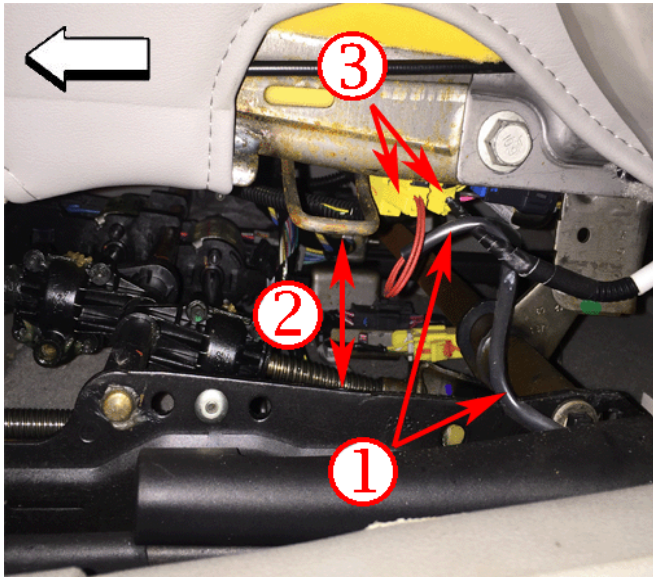
4322447

4. Inspect the seatbelt pretensioner harness for damage. (Harness (1) shown correctly looped and secured rearward, away from pinch points (2), harness connectors (3) located next to cushion).
- If no damage found, route, or loop and secure the harness to the Side Impact Air Bag (SIAB) harness located at the rearmost part of the seat frame.
 - If harness is damaged or cut, depending on the location of the damage, replace the seatbelt pretensioner assembly or the seat harness. **Do not repair harness.** Refer to the Seat Belt Retractor Pretensioner Replacement - Front in SI. Refer to the Electronic Parts Catalog (EPC) using vehicle VIN information for correct part numbers.

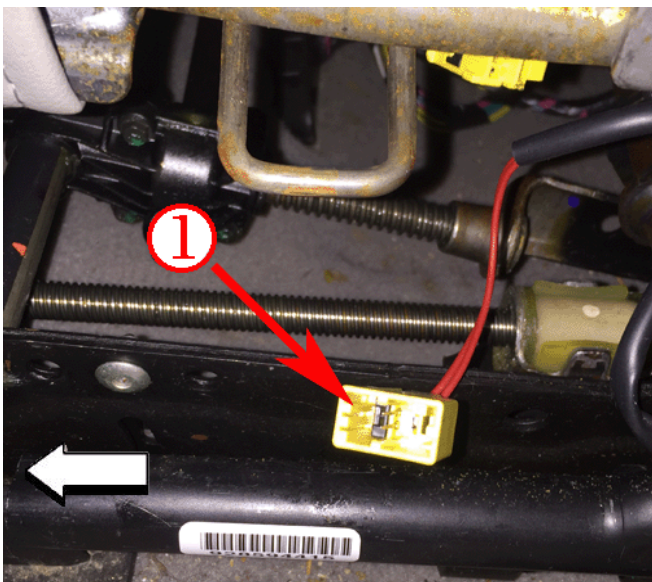
4322450

6. Inspect the connectors (1) for bent or misaligned pins or corrosion.
- If no issues found, apply dielectric grease, using an acid brush or suitable tool, to both male and female ends of the connectors and reconnect.
 - If connector pins are bent, corroded or damaged, replace or perform wiring repair. Refer to Connector Repairs in SI.
