# Service Bulletin

Bulletin No.: 15-NA-082

**Subject:** Clunking Noise from Front of Vehicle During Turns and/or Bumps

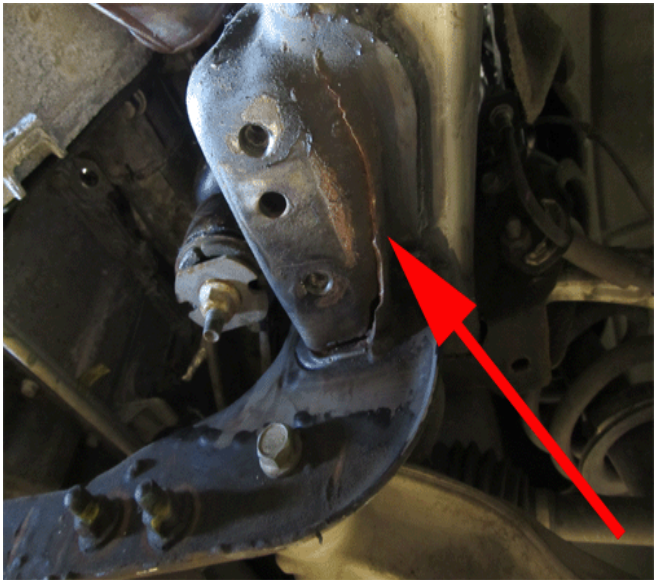
<p style="text-align: right;">4223055</p> <p>This may be caused by a damaged stabilizer shaft frame bracket. There have been some cases in which the bracket is cracked, as shown. This condition has been found to be the result of insufficient welds between the bracket and frame rail. There have been some cases on older vehicles of corrosion affecting the bracket.</p>

If you encounter a vehicle with the above concern, follow the procedure below to install a new stabilizer shaft bracket to the frame.

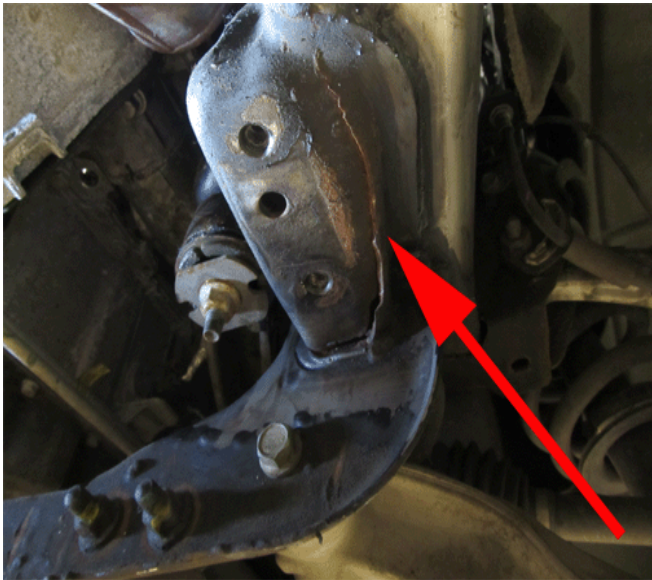
<p style="text-align: right;">4223055</p> <p>This may be caused by a damaged stabilizer shaft frame bracket. There have been some cases in which the bracket is cracked, as shown. This condition has been found to be the result of insufficient welds between the bracket and frame rail. There have been some cases on older vehicles of corrosion affecting the bracket.</p>

If you encounter a vehicle with the above concern, follow the procedure below to install a new stabilizer shaft bracket to the frame.
