Service Bulletin

SPECIAL COVERAGE

SUBJECT: Special Coverage Adjustment - Side Impact Airbag Connectors

MODELS: 2011 Chevrolet Volt

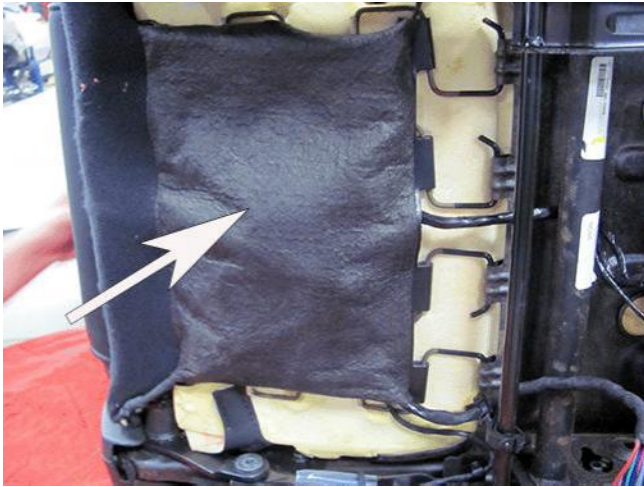
4325289

1. Disable the Supplemental Inflatable Restraints (SIR) system. Refer to *SIR Disabling and Enabling* in SI.
2. Remove the affected seat. Refer to *Driver or Passenger Seat Removal and Installation* in SI.
3. Place the seat on a clean, covered work surface. Position the seat so you can access the yellow Side Impact Airbag (SIAB) harness connectors on the underside of the seat cushion.

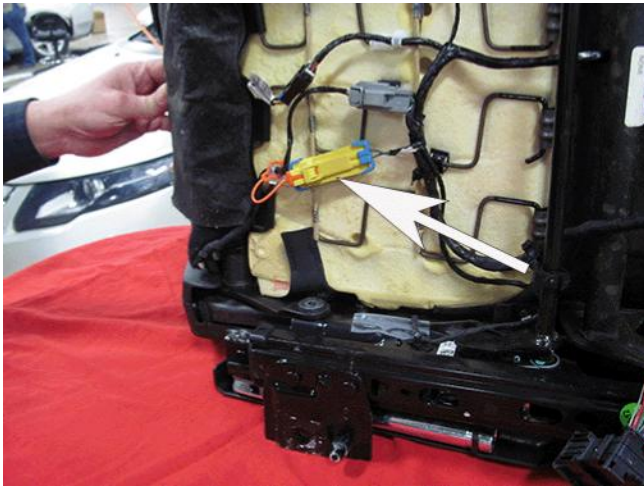
4325291

4. Remove the protective fabric as necessary.

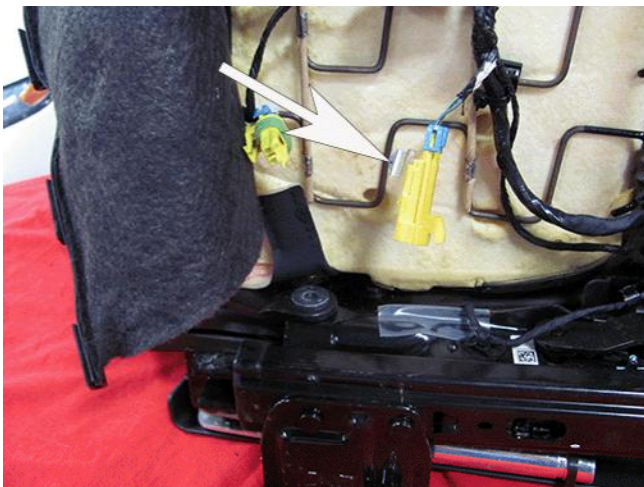
4325293

5. Locate the yellow Side Impact Airbag (SIAB) harness connector.

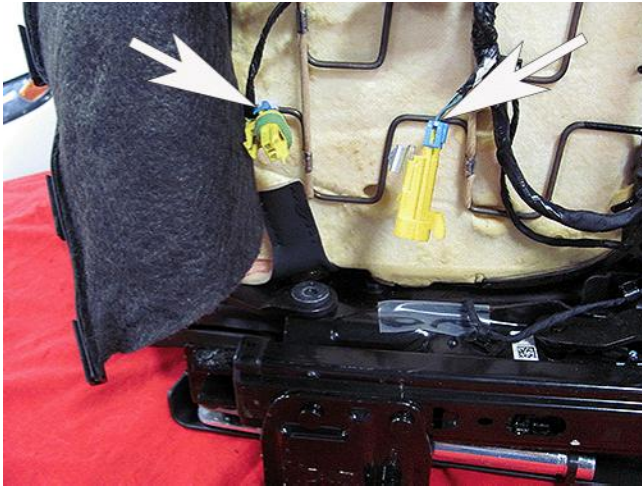
4325294

6. Remove the connector from the seat spring by releasing the metal clip.

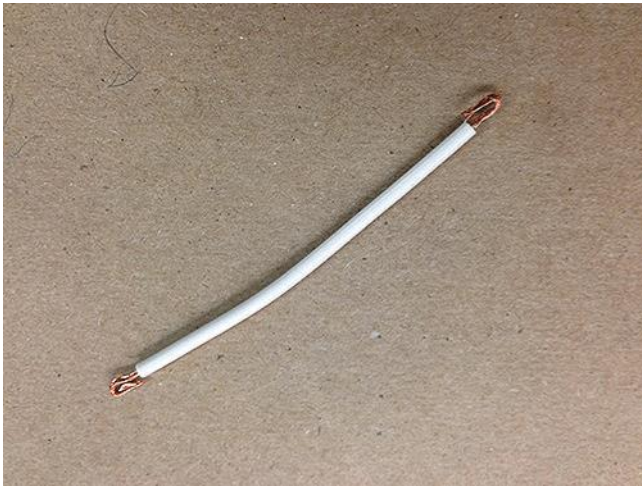
4325295

7. Using side cutters, cut the connectors from both sides of the seat harness as close to the connector as possible.
8. Strip off approximately 13 mm (1/2 in) of insulation from the wiring ends. Fold the wires.
9. Add one approximate 38 mm (1.5 in) section of heat shrink tube to each of the four wires.

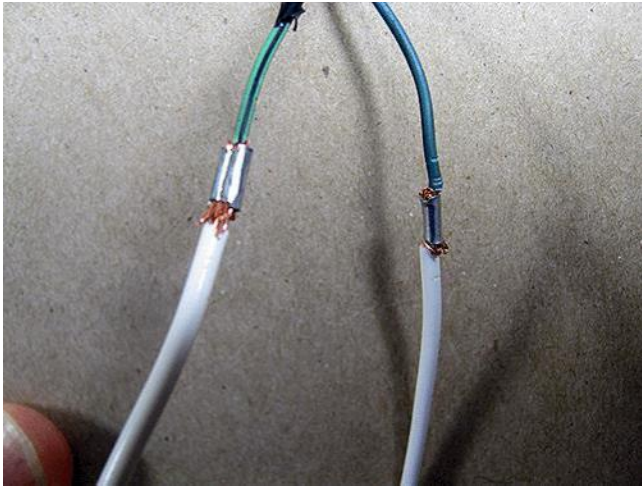
4325296

10. Prepare two approximate 75 mm (3.0 in) length jumper wires. Use locally sourced 0.8 sq mm (18 gauge) wire for the jumper wires. Strip off approximately 13 mm (1/2 in) of insulation from the wiring ends. Fold the wires as shown.
11. Insert the two jumper wires between the four harness wires. Ensure the correct wire colors are aligned.

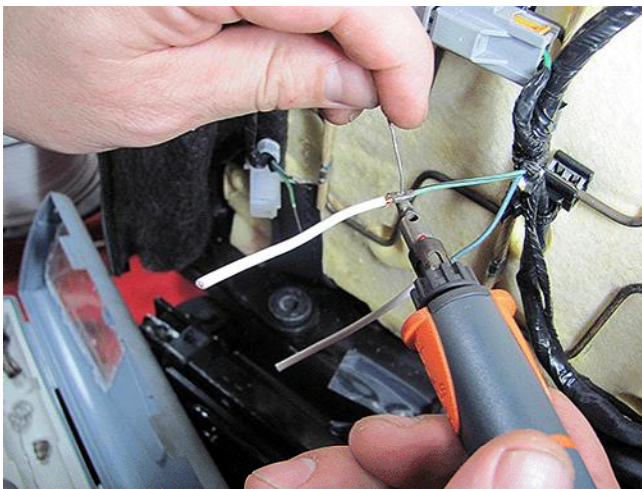
4325297

12. Crimp a splice clip over the joined wires using Special Tool J-38125-8, nest F. Verify the crimp quality. Repeat this crimp process on all four wire connections.

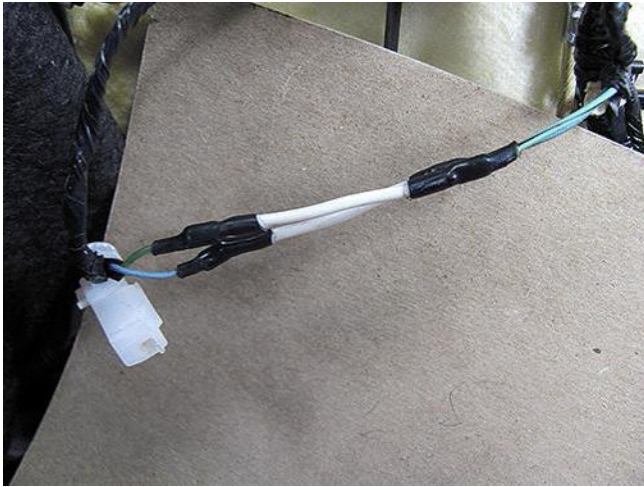
4325298

13. Solder all four crimp and splice clips using the Ultratorch, part number J-38125-5, or another butane fueled soldering iron.
