Service Bulletin

Bulletin No.: 15-NA-043

Subject: Rear Turn Signal Inoperative and/or Turn Indicator Failure Message Displayed in DIC

Brand:	Model:	Model Year:		VIN:		Engine:	Transmission:
		from	to	from	to		
Cadillac	SRX	2015	2015	March 1, 2015	April 30, 2015	All	All

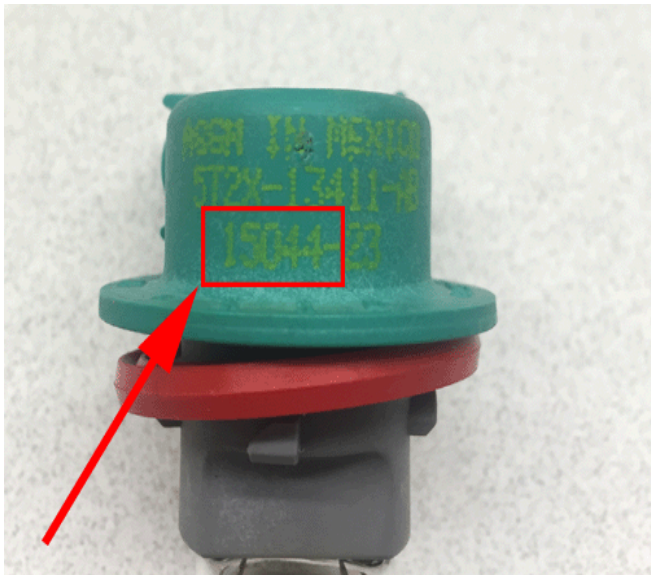
4291162

Condition	Some customers may comment on a rear turn signal inoperative and/or a turn indicator failure message displayed on the DIC.
Cause	This may be caused by an internal failure within the rear turn signal socket.

2. With the rear turn signal bulb socket removed, visually inspect the socket julian date on the back of the socket as illustrated above.
 - If the julian date is within 15032–15120, replace the affected socket.
 - If the julian date does not fall in between 15032–15120, continue normal diagnosis referring to SI.
