Service Bulletin

Bulletin No.: 15-NA-046

Subject: Driver Steering Wheel Airbag Not Flush With Steering Wheel and/or Difficulty Depressing Airbag to Engage Horn

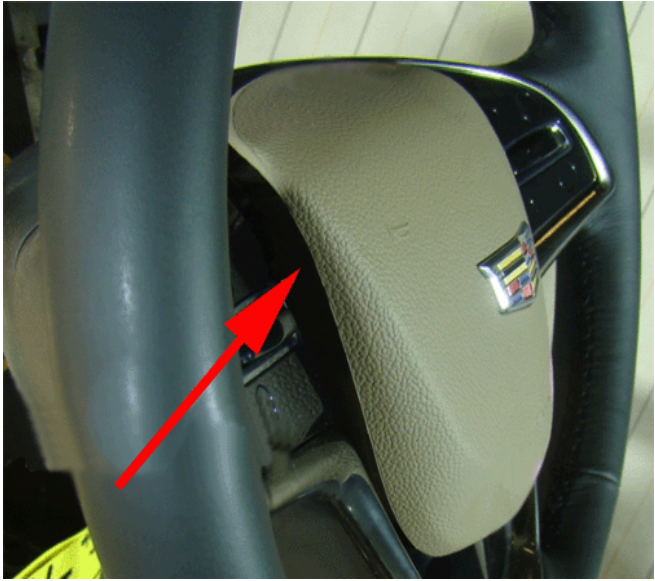
4291790
	Some customers may comment that the steering wheel airbag is not flush to the steering wheel and/or it is difficult to depress airbag to engage the horn.
Cause	This may be caused by the steering wheel inflatable restraint module (steering wheel airbag) not being fully installed into the steering wheel.

If you encounter a vehicle with the above concern and the vehicle falls within the build dates listed above, replace the steering wheel airbag. Refer to Steering Wheel Airbag Replacement in SI.
