# Service Bulletin

Bulletin No.: 15-NA-068

**Subject:** Front Lower Ball Joint and Knuckle Inspection After Road Hazard Tire/Wheel Damage and/or Noise from Front End

Brand:	Model:	Model Year:		VIN:		Engine:	Transmission:
		from	to	from	to		
Chevrolet	Corvette	2014	2016			All	All

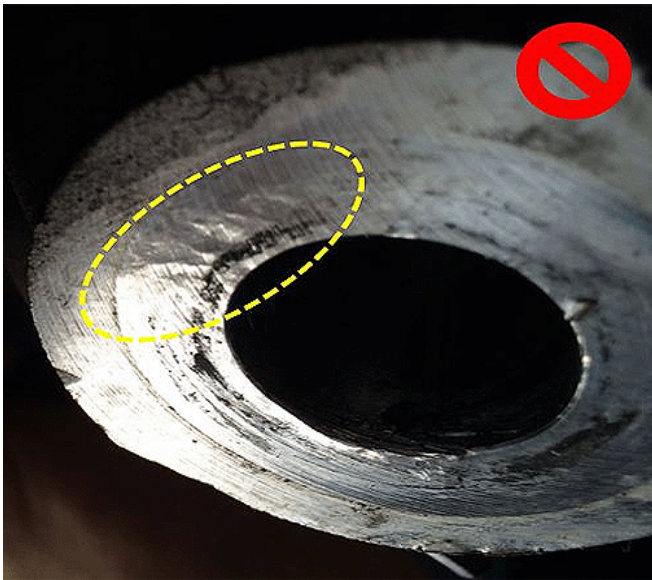
4318039

- 4.4. Remove and discard the lower ball joint nut.
- 4.5. Clean the upper and lower boss surfaces with an approved parts cleaner and rag.
- 4.6. Start by visually inspecting the tapered-hole edges on both top and bottom surfaces of the lower boss of the knuckle, looking for evidence of oblong wear/damage.

- If the knuckle shows **NO** evidence of hole elongation, "bubbling" from yielding, or a failed straight edge test, as indicated throughout step 4 above, continue on to step #5 of this inspection procedure.
  - If the knuckle **DOES** show evidence of hole elongation, "bubbling" from yielding, or a failed straight edge test, it will be necessary to replace the lower control arm and knuckle. Jump ahead to the Lower Control Arm and Steering Knuckle Replacement procedure in SI.
5. Re-seat the ball stud into the tapered hole.

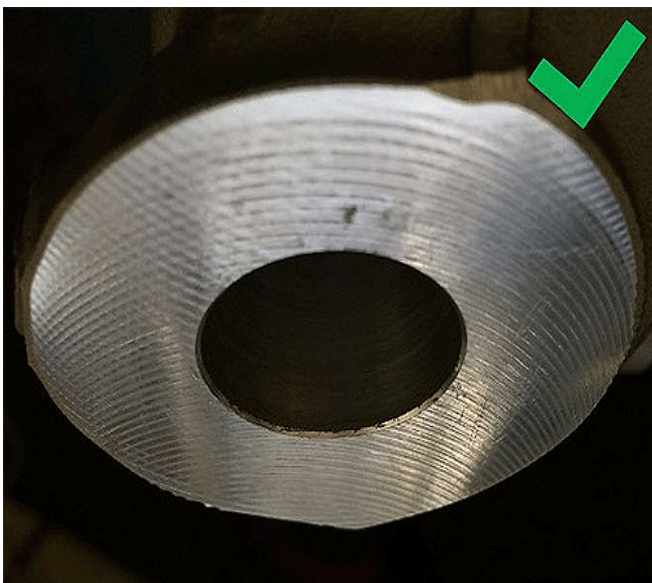
4318044

- 4.7. Next, visually inspect the knuckle's machined lower boss face, looking for evidence of material yielding. Yielding will manifest itself visually on this surface as a "bubbling" condition.

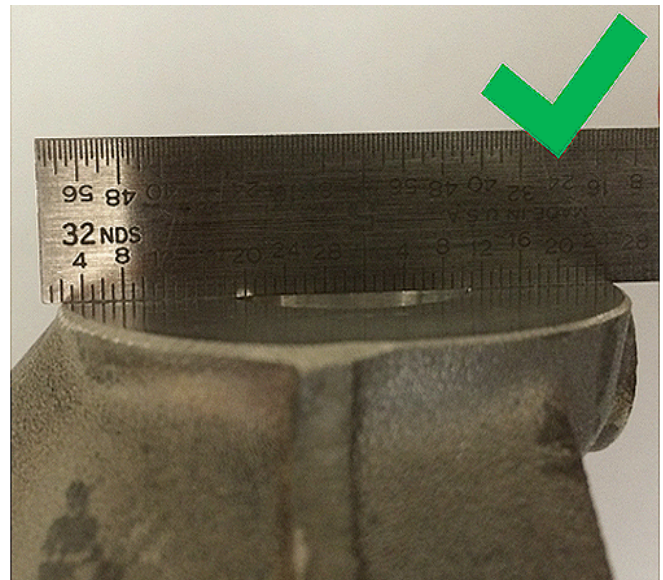
4318054

**Note:** The surface will likely show a uniform pattern of machining marks across the entire face, which should **NOT** be confused with the "bubbling" condition.
