# Service Bulletin

Bulletin No.: 15-NA-073

**Subject:** Difficult to Shift and/or Hard to Get into Gear

Brand:	Model:	Model Year:		VIN:		Engine:	Transmission:
		from	to	from	to		
Chevrolet	Cruze	2012	2016				Manual Transmission (RPO M32)
Chevrolet	Sonic	2012	2016				Manual Transmission (RPO M32)

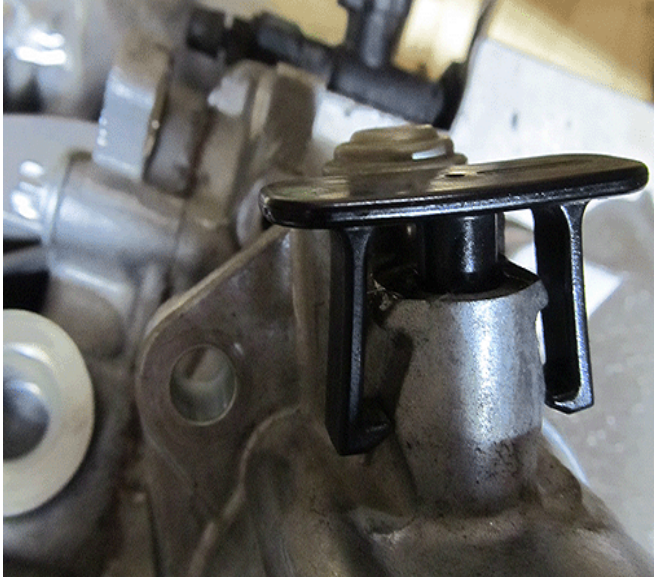
<b>Condition</b>	Some customers may comment on difficulty to shift and/or hard to get into gear.
<b>Cause</b>

<p style="text-align: right; font-size: small;">4321428</p> <p>This condition may be due to the shift tower blocking pin not being fully retracted.</p>
