Program Bulletin

CUSTOMER SATISFACTION PROGRAM

SUBJECT: Material Over Sensing and Diagnostic Module Retaining Moisture

MODELS: 2007-2009 Chevrolet Silverado
2007-2009 GMC Sierra
Currently or Previously Registered in Alaska, Connecticut, Delaware, District of Columbia, Illinois, Indiana, Iowa, Maine, Maryland, Massachusetts, Michigan, Minnesota, Missouri, New Hampshire, New Jersey, New York, Ohio, Pennsylvania, Rhode Island, Vermont, West Virginia, Wisconsin

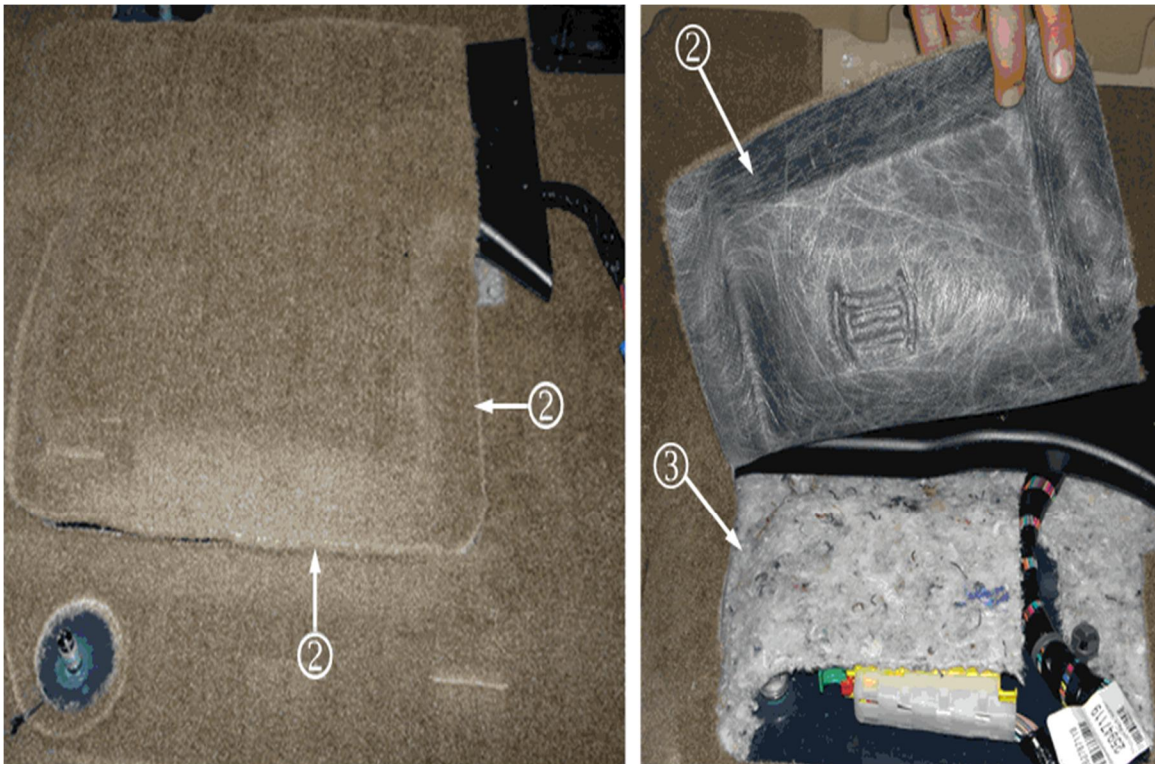
Note: Carpet and cutout flap (2) shown with the driver's seat removed from the vehicle for illustration purposes only. Seat removal is NOT required to gain access to the acoustical pad (3).

Note: If there is no cutout flap or slit on the vinyl flooring, no further action is required unless the SDM requires replacement. If the vehicle is equipped with vinyl flooring with a slit only, insert your hand into the slit and tear out all of the acoustical pad (3) over the top of the SDM.

4. Lift the cutout flap (2) in the carpet or vinyl to gain access to the acoustical pad (3) that covers the SDM.

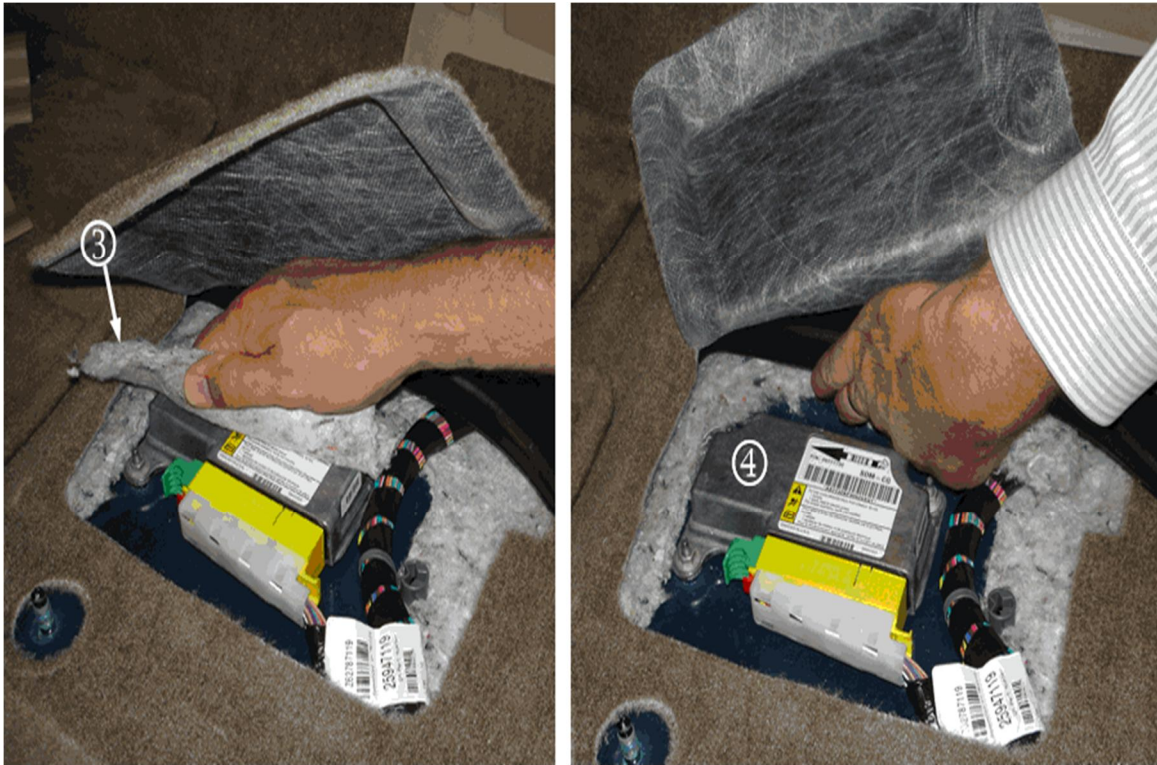
Note: Seat removed for illustration purposes only

5. Using your hand, tear away and remove the acoustical pad (3) that covers the SDM (4). Ensure that there is at least a minimum of 13mm (1/2 inch) clearance between the padding to the SDM (4) and no acoustical pad remains over, or in contact with, the SDM (4).
 - If SDM replacement is NOT required proceed to step 8.
 - If SDM replacement is required, proceed to steps 6-7.
