## Service Bulletin

Bulletin No.: 08-08-57-003F

**Subject:** Floor Wet Under Carpet/Engine Continues to Run with Key Off/Possible No Crank/No Start/Communication Loss/Various Electrical Concerns (Seal Seam)

**Models:** 2008-2016 Buick Enclave  
2009-2016 Chevrolet Traverse  
2007-2016 GMC Acadia  
2007-2010 Saturn OUTLOOK

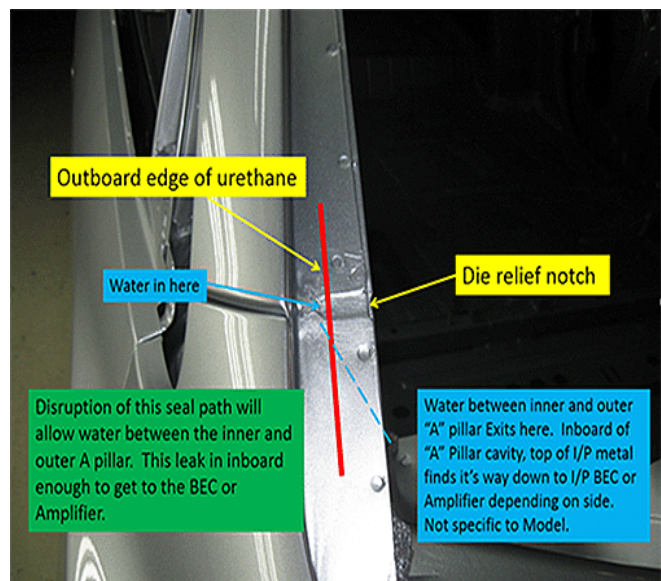
4180308

- Inspect the right side A-pillar/windshield area and water test for any leaks.

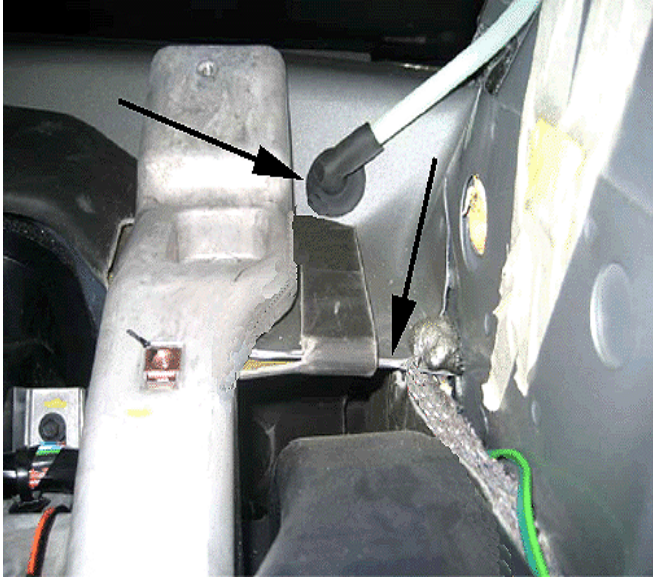
2125552

Water from the right front sunroof drain hose exits the vehicle through the plenum (upper arrow) and may re-enter through the un-sealed seam at the front of the dash. Refer to lower arrow in the illustration.
