10024244
Service Bulletin

Bulletin No.: 08-08-57-003

Subject: Front Floor Wet/Module Communication Loss/Various Electrical Concerns (Seal Seam)

**Models: 2008 Buick Enclave
 2007-2008 GMC Acadia
 2007-2008 Saturn OUTLOOK**

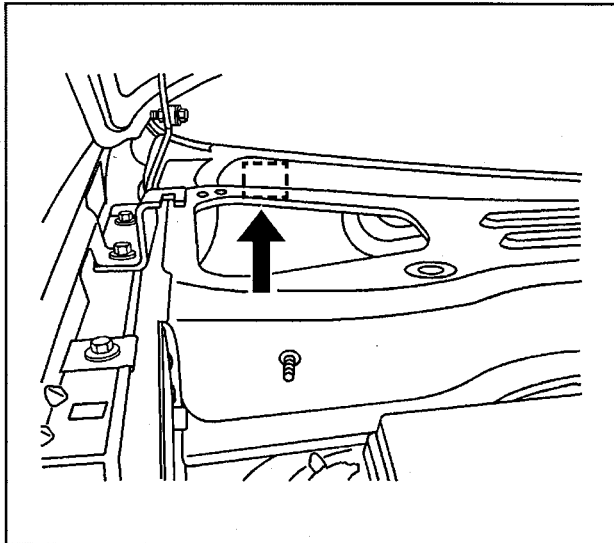
2047234

Water from the right front drain hose exits the vehicle through the plenum and may re-enter through the un-sealed seam at the front of the dash.
