Service Bulletin

Bulletin No.: 08-08-57-003B

Subject: Floor Wet Under Carpet/Engine Continues to Run with Key Off/Possible No Crank/No Start/Communication Loss/Various Electrical Concerns (Seal Seam)

Models: 2008 Buick Enclave
2007–2008 GMC Acadia
2007–2008 Saturn OUTLOOK

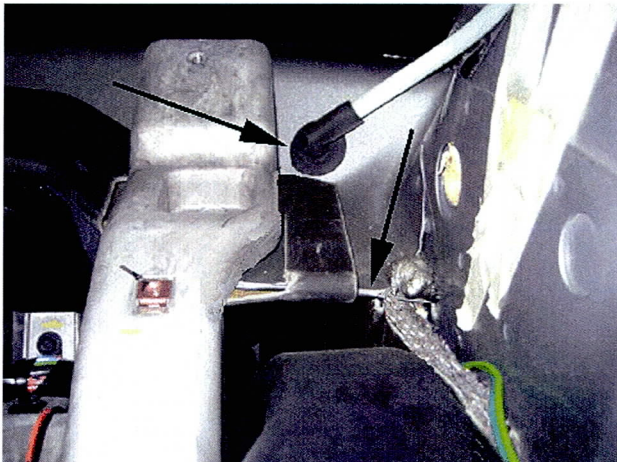
2125552

- Right front floor is wet under carpet.
- A leak on the IP BEC could cause various electrical concerns such as: Engine Continues to Run with Key Off/Possible No Crank/No Start/Communication Loss/Various Electrical Concerns.
- This leak may also cause some communication issues between certain electrical modules due to water dripping on the IP BEC.

Water from the right front sunroof drain hose exits the vehicle through the plenum (upper arrow) and may re-enter through the un-sealed seam at the front of the dash. Refer to lower arrow in the illustration.

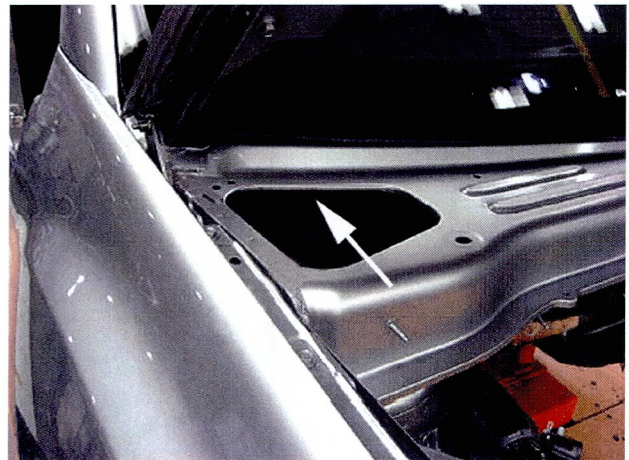
2125557

Important: Inspect the IP BEC for wetness and/or any green colored corrosion.

1. Remove the windshield wipers and cowl screen where sealing repair is to be done.

2. In order to verify the waterleak, run a small amount of water into the square hole inside the cowl while looking at the IP BEC.
3. Allow the water to dry and proceed to step 4.
