# SB-10032406-3849

Bulletin No.: PIT4898B

Date: November, 2010

**Subject:** The Drivers Power Seat Inoperative or SIR Light Is On With DTC's B0014 B0015  
**Models:** 2010 Chevrolet Equinox

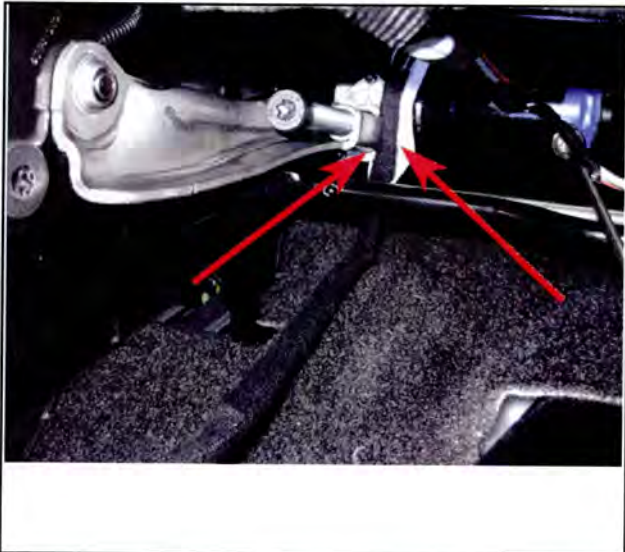
2321545

In rare cases, customers may complain that the driver's power seat is inoperative and/or the SIR light is coming on intermittently. When diagnosing the vehicle, DTC's B0014 and/or B0015 may be found in the SDM. The "PWR SEAT LT" fuse may be open in the under hood fuse block. This may be caused by a wire harness getting pinched under the driver's seat, between the seat frame and the power seat motor (see picture above). This concern happens when the seat is moved to the up position. This is applicable for both 4 and 8 way power seats.

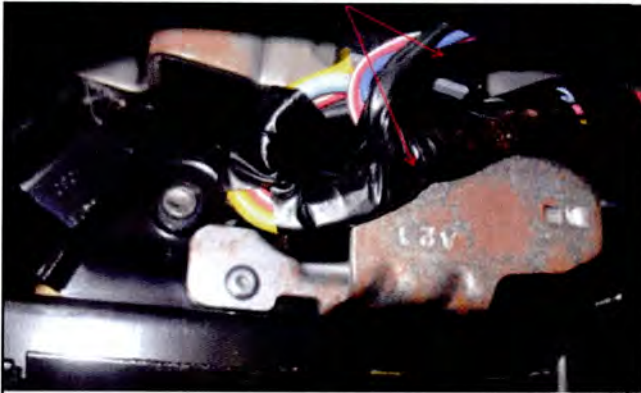
2526551

On vehicles equipped with 4 way seats, drivers side seat wiring to switch can become pinched and or chafe on side shield bracket. This can add more pressure from the harness to the seat switch and damage the seat switch. This condition occurs when the seat is in the full down position.

Add abrasion tape, mastic patch or equivalent over bracket to protect harness. Adding abrasion tape or conduit will cause harness to be too stiff and will aggravate wire to switch issues.

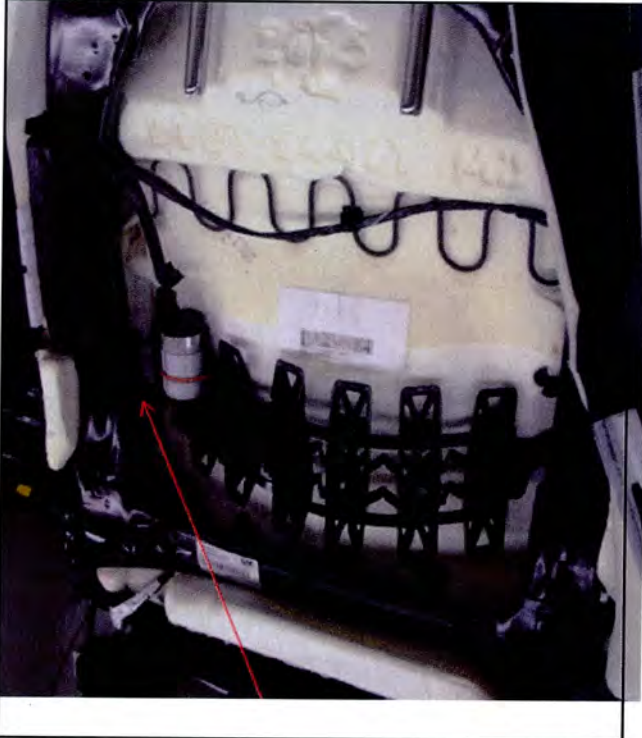
2526552

Driver's side seat wiring harness can chafe on burr on seat back upper metal frame.

Add abrasion tape and or wiring conduit to harness in this area. Additionally, file burr smooth.

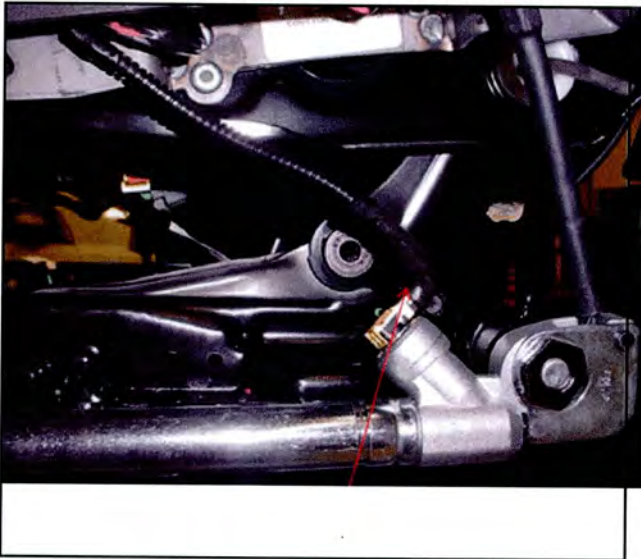
2526555

Driver side 8 way power seat pre-tensioner branch/connection in tension when seat is in full up position. May cause air bag code to set. Tension at connector may cause broken/pulled out wires at connector

Reposition the wire harness branch 10mm to 20mm for more slack.

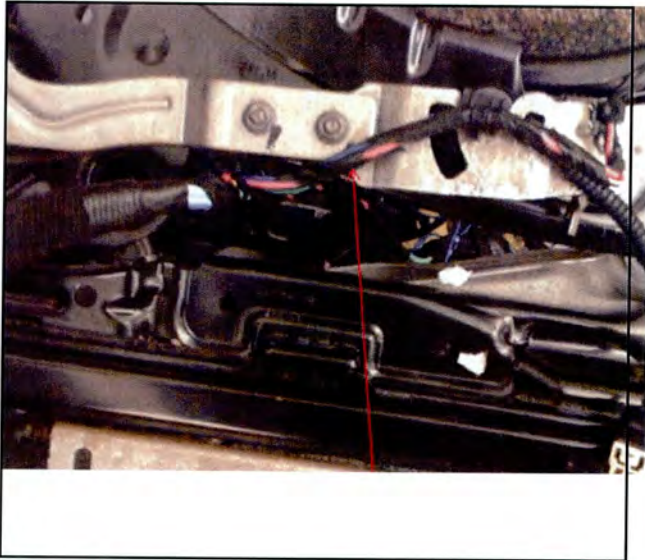
2526558

Pretensioner/Lumbar branch on driver's side 8 way power seat may become pinched or trapped under outboard side bracket.

Add conduit or equivalent protective covering wire harness
