Bulletin No.: PIT4898

**Subject:** The SIR Light Is On With DTC's

**Models:** 2010 Chevrolet Equinox

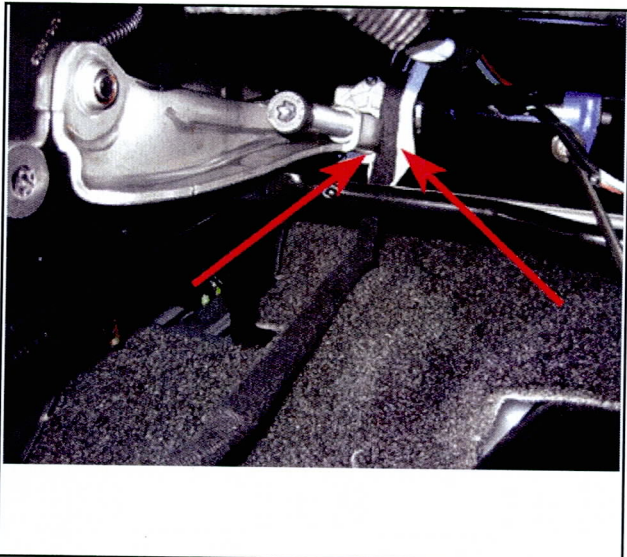
2321545

Some customers may complain that the driver's power seat is inoperative and/or the SIR light is coming on intermittently. When diagnosing the vehicle, DTC's B0014 and/or B0015 may be found in the SDM. The "PWR SEAT LT" fuse may be open in the underhood fuse block. This may be caused by a wire harness getting pinched under the driver's seat, between the seat frame and the power seat motor. This concern happens when the seat is moved to the up position.

Check the wire harness under the seat for contact between the seat frame and the power seat motor (See picture above). The picture above is looking from the back of the seat, looking forward near the left seat track. If any wires are found to be damaged, repair them as necessary and reroute the wire harness to prevent any further contact.
