Service Bulletin

Bulletin No.: 10-08-42-001E

Date: May, 2015

Subject: Low Beam Headlamp Bulb Diagnosis/Replacement (Inspect Bulb and Connector)

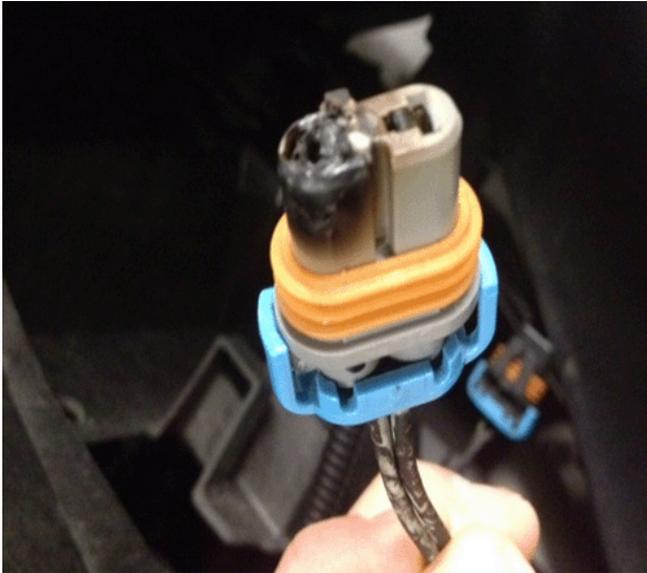
3991128

- If the connector is discolored at the bulb interface, replace the connector (service pigtail listed below) and bulb.
3. Cut the wires of the connector approximately 45 mm (1¾ in) from the connector and splice in the service pigtail connector. Ensure that the splices are not above the connector when re-installing.
