File In Section: Service Bulletin

Bulletin No.: PI0235A

Subject: Exhaust Leak or Vibration/Rattle Noise at Approximately 2500 RPM, Fuel Smell, Oily Substance on Exhaust Downpipe

Models: 2011 Chevrolet Silverado 2500HD/3500HD, Express 2500/3500/4500
2011 GMC Sierra 2500HD/3500HD, Savana 2500/3500/4500
Equipped with 6.6L Duramax Diesel Engine (RPOs LML or LGH)

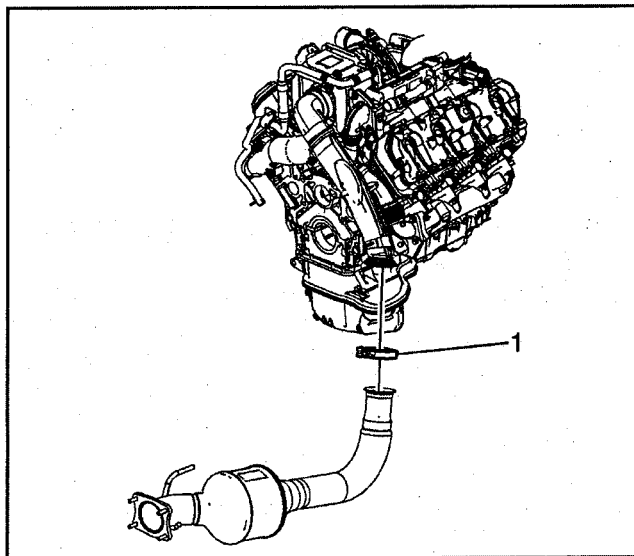
1862851

Some customers may comment on a fuel smell intermittently when driving the vehicle, usually after coming to a stop. They also may comment on a possible exhaust leak or vibration/rattle noise at approximately 2500 RPM. Upon further diagnosis, a technician may notice what appears to be an oily substance at the bottom of the turbocharger's exhaust downpipe.

The cause of this condition may be that the clamp for the exhaust manifold to exhaust down pipe connection may be loose or out of position. The fuel smell or appearance of an oily substance could be from the Hydro-Carbon Injection process used during the diesel particulate filter (DPF) regeneration event.

With the truck cooled down, loosen the exhaust clamp (1), visually inspect the joint integrity and reposition the exhaust providing proper alignment between the down pipe and the exhaust manifold. This could require multiple attempts to correctly align the pipe to exhaust manifold. Loosening or disconnecting the 4-bolt flange mid-joint may make this process easier.

To ensure that the condition has been corrected, use the Tech 2® to enable exhaust filter regeneration by selecting the "DPF Regeneration Enable" in the Tech 2, then drive the vehicle for approximately 10 minutes at speeds above 48 km/h (30 mph). After 10 minutes of continuous driving, you should then conduct some stop-and-go-style driving to verify that there is no longer any exhaust or fuel odor entering the cabin and visually inspect the exhaust joint at the exhaust clamp (1 in the drawing above).
