Service Bulletin

Bulletin No.: PI0235D

Date: August, 2012

Subject: Exhaust Leak or Vibration/Rattle Noise at Approximately 900 RPM, Fuel Smell, White Smoke, Oily Substance on Exhaust Downpipe

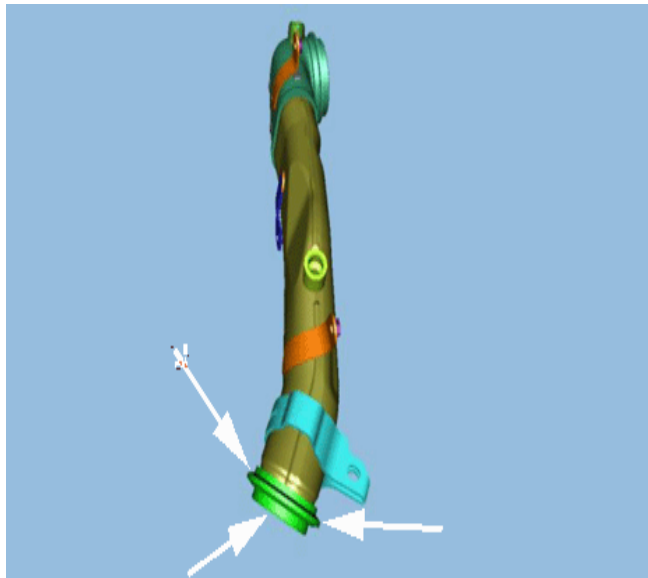
2749618

Note: The illustration above is the updated turbocharger exhaust pipe with a pilot flange.

If the above alignment procedure does not correct the condition, the turbocharger exhaust pipe may need to be replaced on trucks built prior to the breakpoints listed below with an updated turbocharger exhaust pipe with a pilot flange. If the turbocharger exhaust pipe has the new flange, do not replace it. Refer to the Turbocharger Exhaust Pipe Replacement procedure in SI.

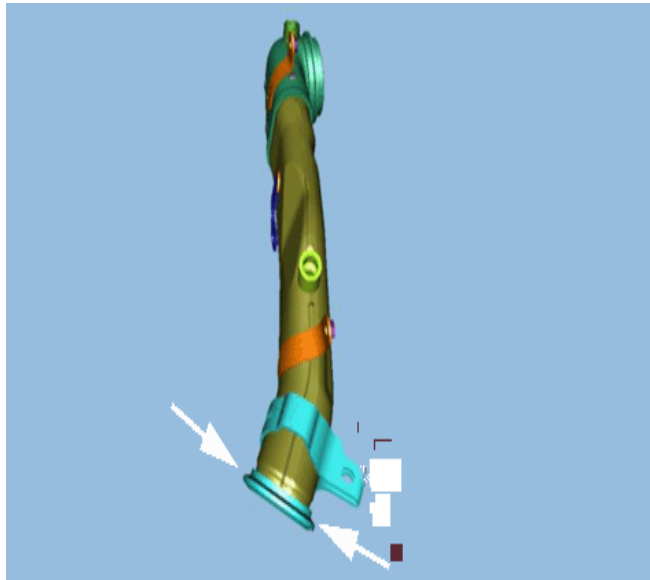
2749630

Note: The illustration above is the turbocharger exhaust pipe without a pilot flange.
