Service Bulletin

Bulletin No.: PI0235F

Subject: Exhaust Leak or Vibration/Rattle Noise at Approximately 900 RPM, Fuel Smell, White Smoke, Oily Substance on Exhaust Downpipe

Models: 2011-2013 Chevrolet Express 2500/3500/4500, Silverado 2500HD/3500HD
2011-2013 GMC Savana 2500/3500/4500, Sierra 2500HD/3500HD
Equipped with 6.6L Duramax™ Diesel Engine (RPOs LML or LGH)

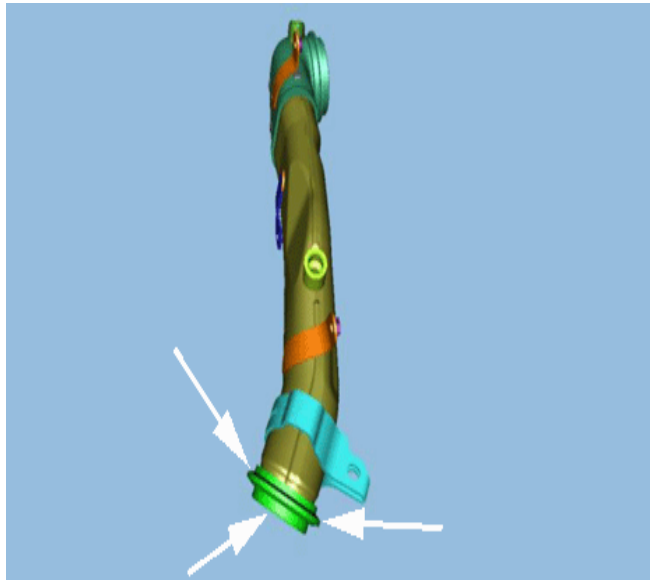
2749618

Note: The illustration above is the updated turbocharger exhaust pipe with a pilot flange.

If the above alignment procedure does not correct the condition, the turbocharger exhaust pipe may need to be replaced on trucks built prior to the breakpoints listed below with an updated turbocharger exhaust pipe with a pilot flange. If the turbocharger exhaust pipe has the new flange, you should not need to replace it. Refer to the Turbocharger Exhaust Pipe Replacement procedure in SI.

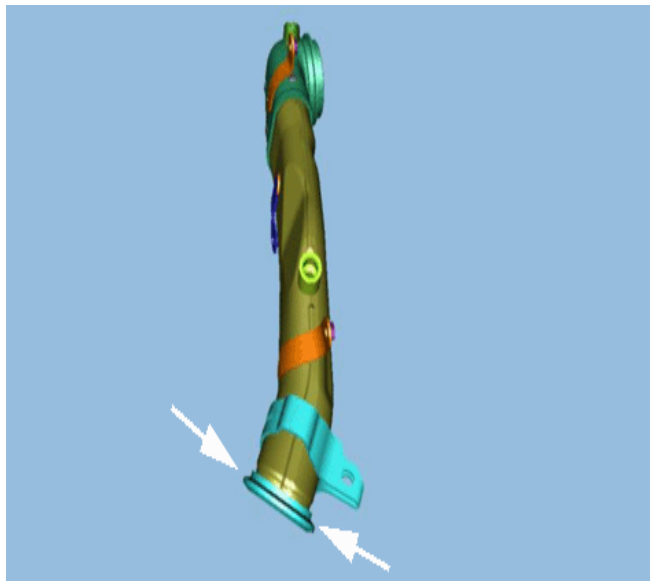
2749630

Note: The illustration above is the turbocharger exhaust pipe without a pilot flange.
