Service Bulletin

Bulletin No.: PI0699

Subject: Gauge Fluctuation, Various DTCs, Wiring Harness Chafing/Rubbing on A/C Line

Models: 2011-2012 Chevrolet Silverado
2011-2012 GMC Sierra
Equipped with 6.6L Duramax™ Diesel Engine (RPO LML)

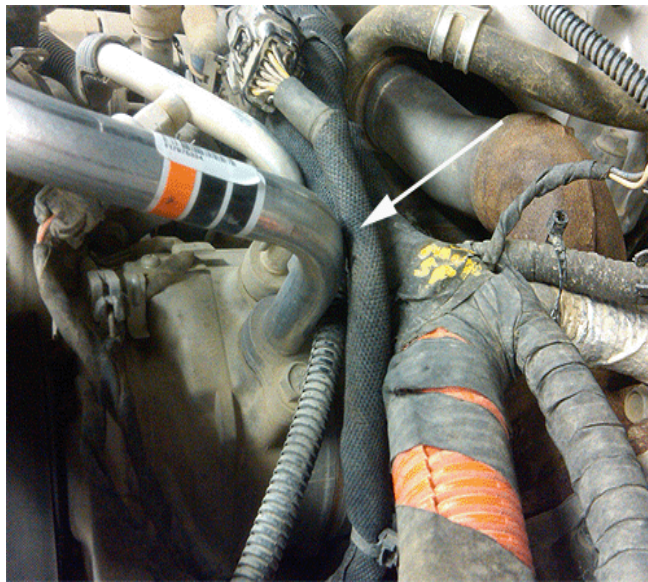
2787379

Technicians may find one or more of the following DTCs set: P0521, P0522, P0523, P125A, P125B, P128E, P2294, P2295, P2296, P00CA, P0090, P00CA, P0091, P0092, P0087, P0088, P0182, P0183, P1088.
The engine wiring harness may be rubbing on the A/C line.
