Service Bulletin

Bulletin No.: PI0699A

Subject: Gauge Fluctuation, Various DTCs, Wiring Harness Chafing/Rubbing on A/C Line

Models: 2011-2012 Chevrolet Silverado
2011-2012 GMC Sierra
Equipped with 6.6L Duramax™ Diesel Engine (RPO LML)

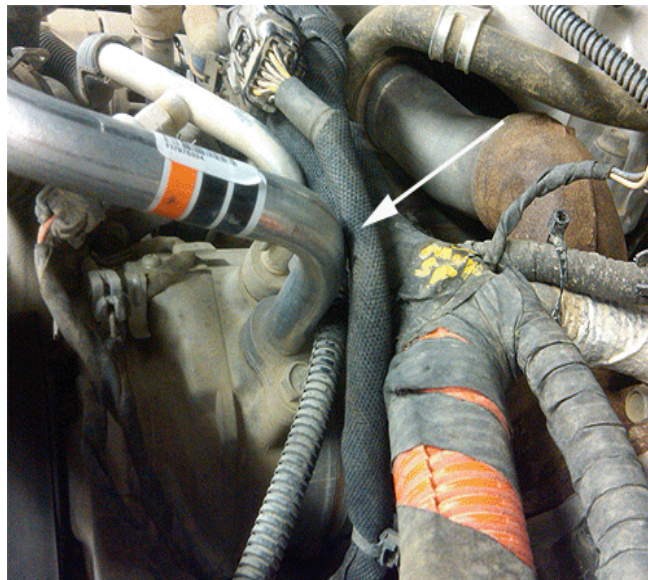
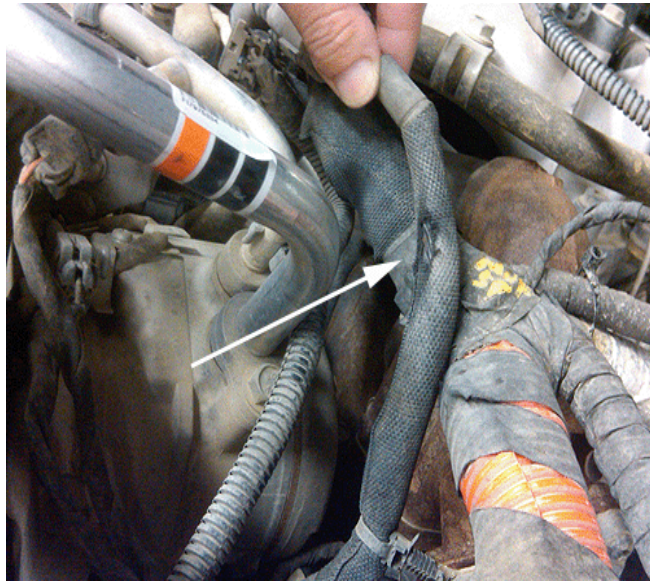
2787005

Some customers may comment that the oil pressure, oil level and/or the coolant temperature gauge fluctuates. Technicians may find one or more of the following DTCs set: P0193, P0341, P0521, P0522, P0523, P0641, P125A, P125B, P128E, P2294, P2295, P2296, P00CA, P0090, P00CA, P0091, P0092, P0087, P0088, P0182, P0183, P1088.

The engine wiring harness may be rubbing on the A/C line.

Repair the wiring harness and install a tie strap to the area shown above.
Refer to SI for wiring repairs.
